## Case History

### Geotechnical damage caused by the 2010 Maule, Chile earthquake

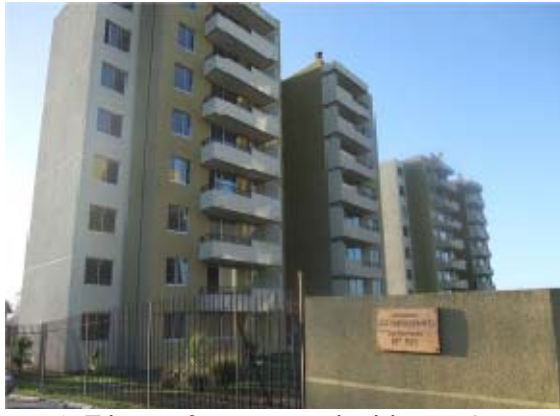
The actual number of liquefied sites was quite small in spite of the large earthquake magnitude. This is probably because the low level of annual precipitation does not make many water-saturated sandy subsoil. The reconnaissance survey detected liquefaction at fill or replaced backfill in and around Concepción only, except the tailing dam at Las Palmas. In Concepción area, subsoil liquefaction caused settlement of buildings and houses as well as uplift of underground tanks at sites shown in Fig. 3. Photo 1 demonstrates a 0.77-degree tilting of an 8-storied apartment building at Los Presidentes in Hualpén. Sand boils were found around the building to verify the occurrence of liquefaction. As the original topography here was swamp, subsurface soil was excavated down to the depth of 4 m and then sand was placed at the time of construction (see Fig. 4). Ground water table was as shallow as 1.0 m below the surface, and it made the effects of subsoil liquefaction more influential. Similar settlement occurred to a 5-storied hospital building in Curanilahue at about 30 km south of Concepción.

Photo 1 Tilting of apartment building at Los Presidentes

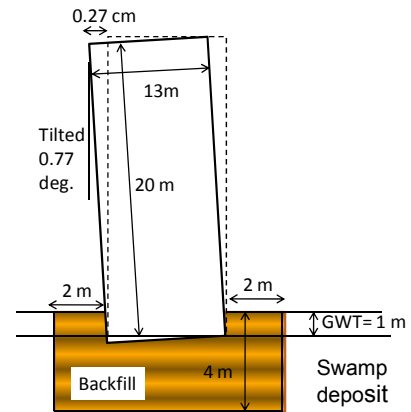
Fig. 4 Schematic cross section of tilted building

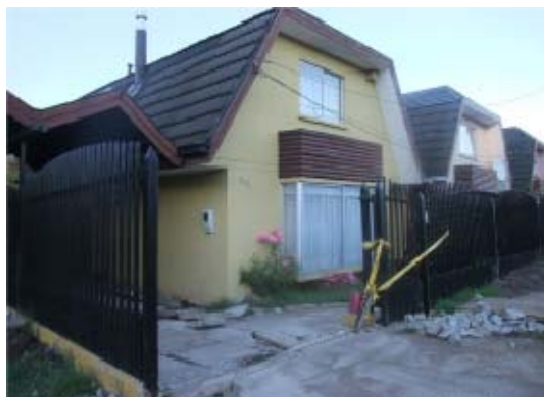
Many houses settled in three housing lots in Concepción as shown in Photo 2. The maximum settlement was about 17 cm. Because the original topography here was swamp as well, the backfilled sand in the swamp liquefied and caused house to subside. Furthermore, underground tanks uplifted in cities of Concepción, Chillan, and Arauco. Photo 3 shows uplifted sewage tanks. It seems that backfilled sand liquefied and caused this uplift.

Photo 2 17-cm Subsidence of houses in Bayona, San Pedro de la Paz

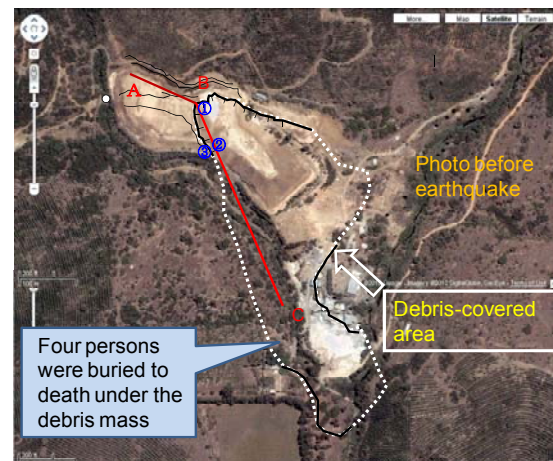
Liquefaction of mine tailings occurred at Las Palmas near Curico, Veta del Agua, and La Florida (Fig. 5). Among them, the authors were able to visit the significant damage at Las Palmas. This tailing dam was used for wastes from a gold mine between 1981 and 1997. An abandoned tailing dam collapsed as shown in Photo 6. Photo 7 illustrates details of the collapsed dam. Accordingly, water and liquefied tailings erupted from many cracks at the surface (see Photo 8). The liquefied mine tailings flowed down about 400 m and hit a farmer's house (Photo 6). Consequently, four people were buried to death under the tailing mass.

Photo 6 Extent of damage at Las Palmas tailing dam.

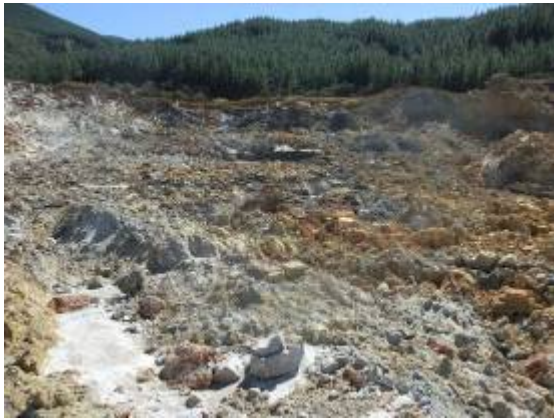
Photo 7 Tailing deposit after liquefaction

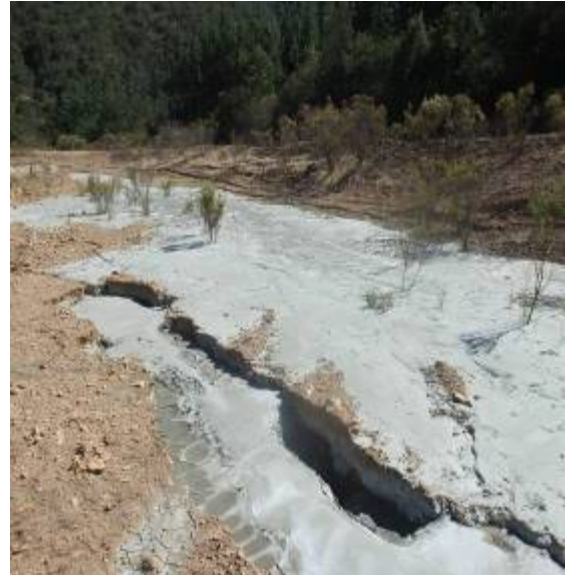
Photo 8 Eruption of liquefied tailings at Las Palmas

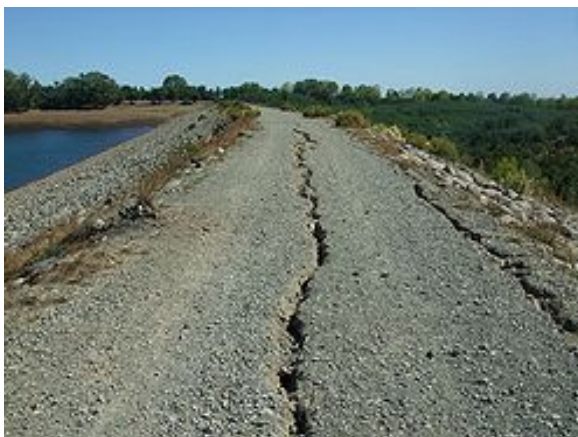
Coihueco Dam is situated at around 130 km to the east of Concepción. It is an earth dam and measures 975 m in length, 31 m in the maximum height, 19 degrees in the upstream slope, and 21 degrees in the downstream slope. The reservoir area is 2.26 million m<sup>2</sup>. Photo 9 indicates two longitudinal cracks along the crest of the dam; one in the centre and the other at the downstream (right side) shoulder. The width of the crest is 5.2 m. The depth of the crack reached at maximum 1.9 m. Photo 10 demonstrates the downward slip movement of the slope on the reservoir side. This movement resulted in at maximum 3.3 m subsidence near the shoulder.

Photo 9 Longitudinal cracks at the crest of Coihueco Dam

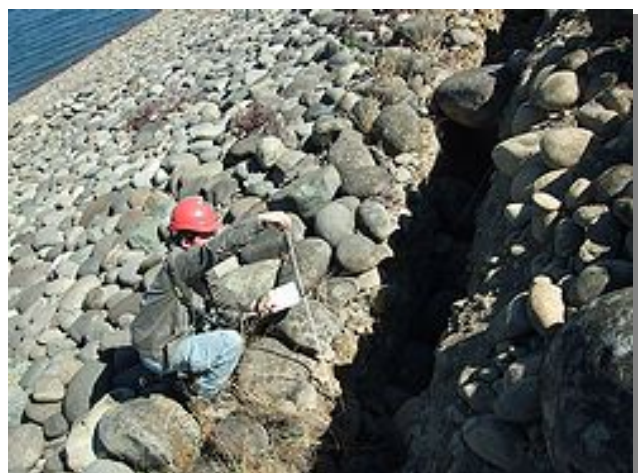
Photo 10 Downward slope movement in upstream face

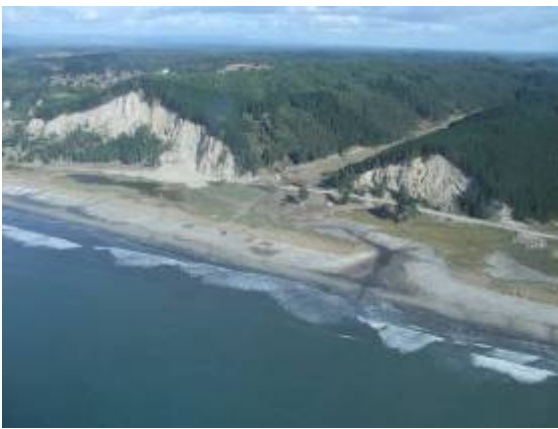
It was fortunate that the size of failures in natural slopes was small. This is because the Andes Mountains where there are many unstable slopes were far from the earthquake-affected area. The Coastal Mountains conversely do not have many steep slopes except cliffs at the coast. Therefore, the present report on natural terrain addresses only the coastal region. There are many steep cliffs along the coast from Arauco to Lebu through Cape Lavapie and they are subject to shallow failures. Photo 11 and Photo 12 indicate surface failures near Arauco and Cape Lavapie, respectively. Height of the cliff shown in Photo 11 is about 100 m.

Photo 11 Slope failure at Las Peñas near Arauco

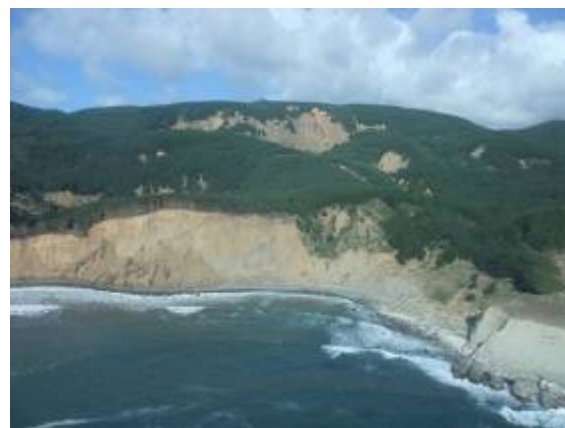
Photo 12 Slope failure at Lavapié

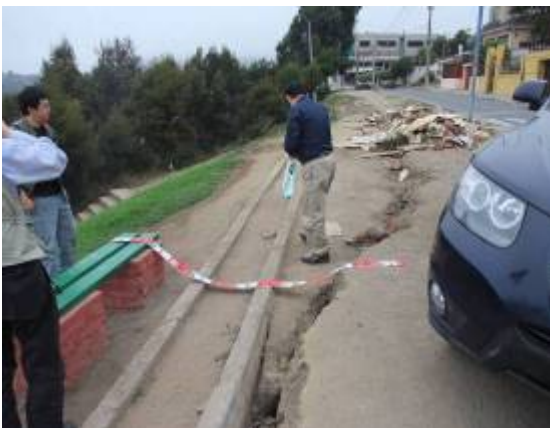
Photo 13 Minor slope failure at San Antonio

Although being very minor, a slope failure with the longest epicentral distance occurred in San Antonio (Photo 13). Its epicentral distance of about 300 km is plotted against the seismic magnitude in Fig. 6 to support the relationship between magnitude and maximum distance of slope failure that was proposed in the Seismic Zoning Manual by TC4 (TC4, 1999). The plotted point is between two curves for dry countries and wet countries. Because the slope failure in Photo 13 is very minor, it may be reasonable to shift the point to the left. Anyway, although the magnitude of the earthquake was huge, the size of slope-failure area was small as compared with that in wet countries.

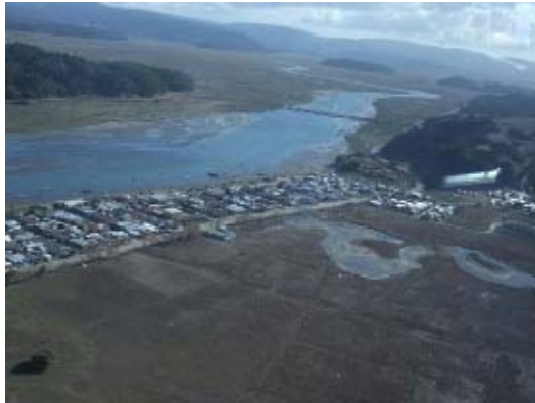
Photo 14 Peaty ground in and around Tubul

The subsoil condition between Arouco and Tubul consists of very soft and peaty soil (Photo 14). Consequently, three bridge girders fell down (Photo 15) and approach embankments collapsed as shown in Photos 16 and 17. The mechanism of the collapse of girders needs further investigation, but the effects of soil condition deserve careful study.

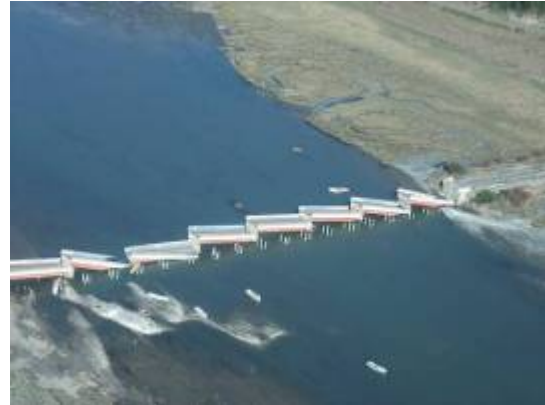
Photo 15 Collapsed bridge in Tubul

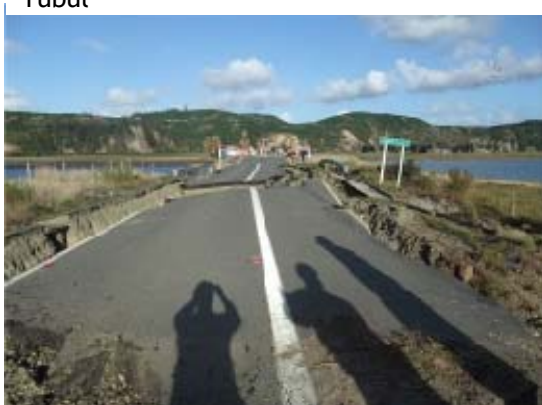
Photo 16 Collapsed approach embankment of Raqui II bridge

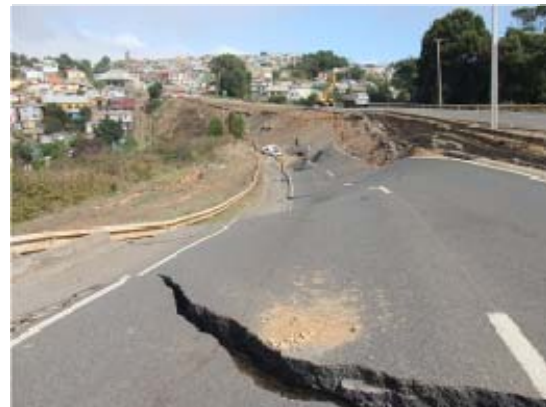
Photo 17 Big slide of road embankment in Lota Norte

In Chile, road embankment is generally constructed only at approaches to bridges. Thus, damaged embankment was found at a limited number of places. Photo 17 shows the biggest failure of road embankment that occurred in Lota. This embankment was constructed upon a swampy soil with a height of 16 m. Its construction material was clean sand. It seems therefore that pore water pressure increased at the bottom of the embankment during shaking, leading to loss of shear strength and shear failure.

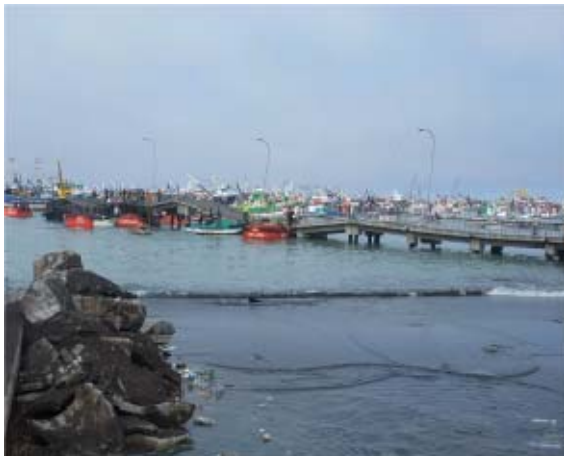
Coronel Harbor is located at about 450km to the south of Valparaiso. A distortion occurred in a fishermen's pier there (Photo 18). The damaged structure connects the land and the main part of the harbor and is supported by a pile foundation. Because substantial translation and tension cracks were found on the land side of the pier (Photo 19), it is inferred that the structure was subjected to compression from the land side, and, because of the very rigid foundation of the main part of the offshore pier, the connecting part developed significant compressional deformation and buckling. This soil-structure interaction deserves further study. Note that two larger commercial piers next to this place received only minor effect from the earthquake and were able to start operation one day after the earthquake.

Photo 18 Damaged pier in Coronel

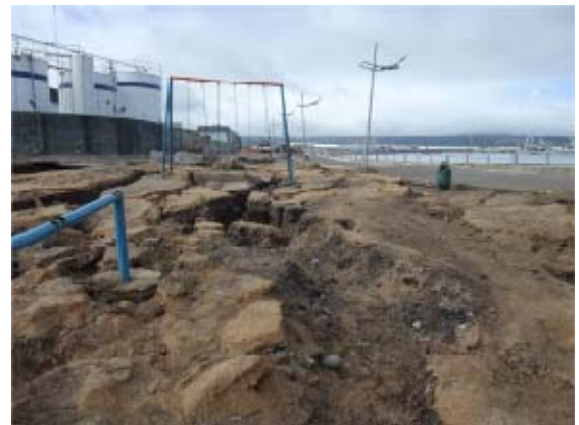
Photo 19 Lateral flow of soil adjacent to the pier

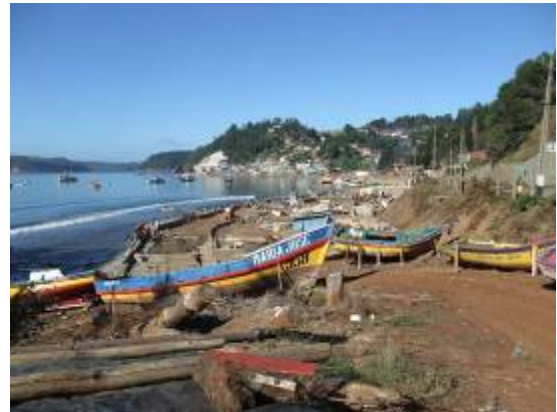
Photo 20 Tsunami damage near Cape Blanca

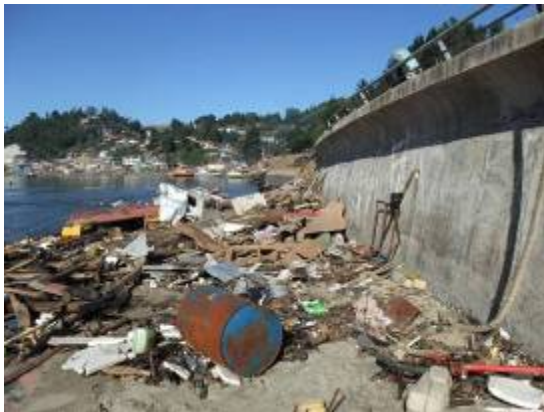
Tsunami disaster was reported widely after the earthquake. The height of the wave was 5.6 to 28.3 m in Constitución, 5.3 to 7.3 m in Dichato, 2.8 to 6.4 m in Talcahuano, and 5.2 m in San Antonio. High waves claimed significant human loss and destroyed many structures. One of the reasons for different tsunami heights at different places is the local topography. This section addresses the Coliumo Bay and Dichato area for example (Fig. 7). Photo 20 shows the total devastation near Cape Blanca. This damage occurred on the southeastern side of the cape facing the Coliumo Bay. This is in a clear contrast with the Pacific Ocean side of the cape where no significant damage occurred. It deserves attention that a sea wall in this damaged area functioned satisfactorily (Photo 21).

Photo 21 Successful performance of sea wall in Cape Blanca area.

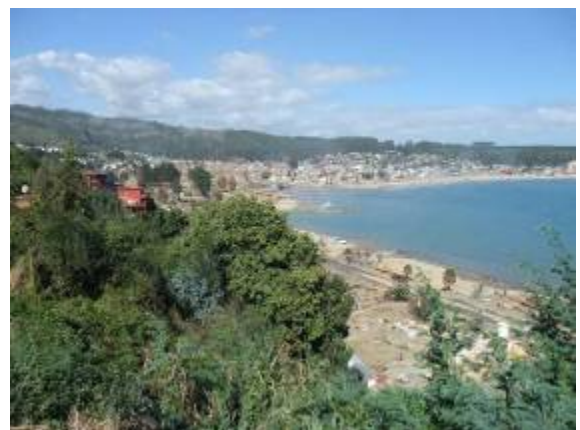
Photo 22 Tsunami erosion in coastal area of Dichato

Photo 22 indicates a long-distance view of Dichato. Although it is not visible in this photograph, the coast of this town was eroded by the tsunami as shown in Photo 23. It is noteworthy that even an underground facility was affected by tsunami-induced erosion of soil; see Photo 24. Photos 25 and 26 demonstrate effects of foundation on damage extent of houses. The house in Photo 25 floated when the water level rose and was transported over a long distance. In contrast, the house in Photo 26 was tightly connected to the foundation and was able to stay in the same place. The intact shape of this house may suggest that the impact force of the tsunami was not very strong. Finally, Photo 27 presents an interesting case where a 6-m-high road embankment protected a freight container yard from the tsunami attack.

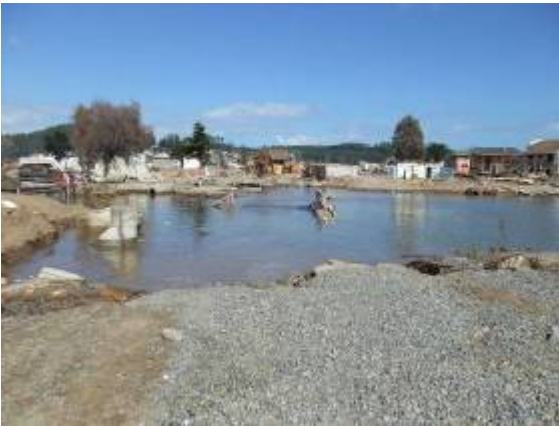
Photo 23 Tsunami-induced erosion in Dichato

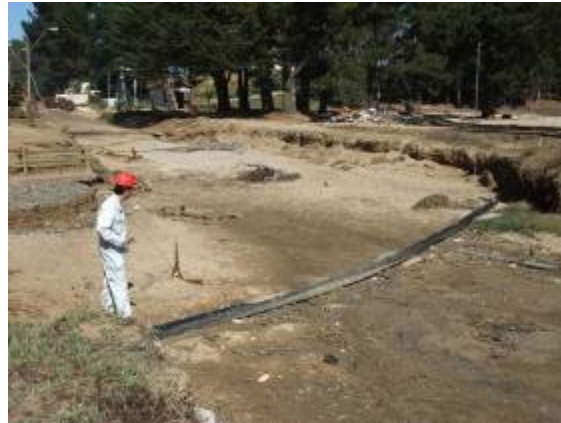
Photo 24 Exposure of buried lifeline after tsunami erosion

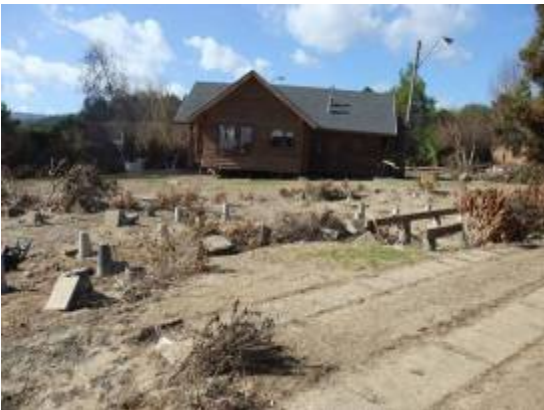
Photo 25 House that floated when tsunami came

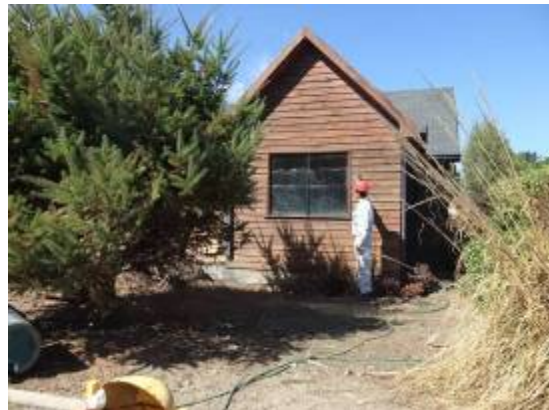
Photo 26 House that did not float when tsunami came

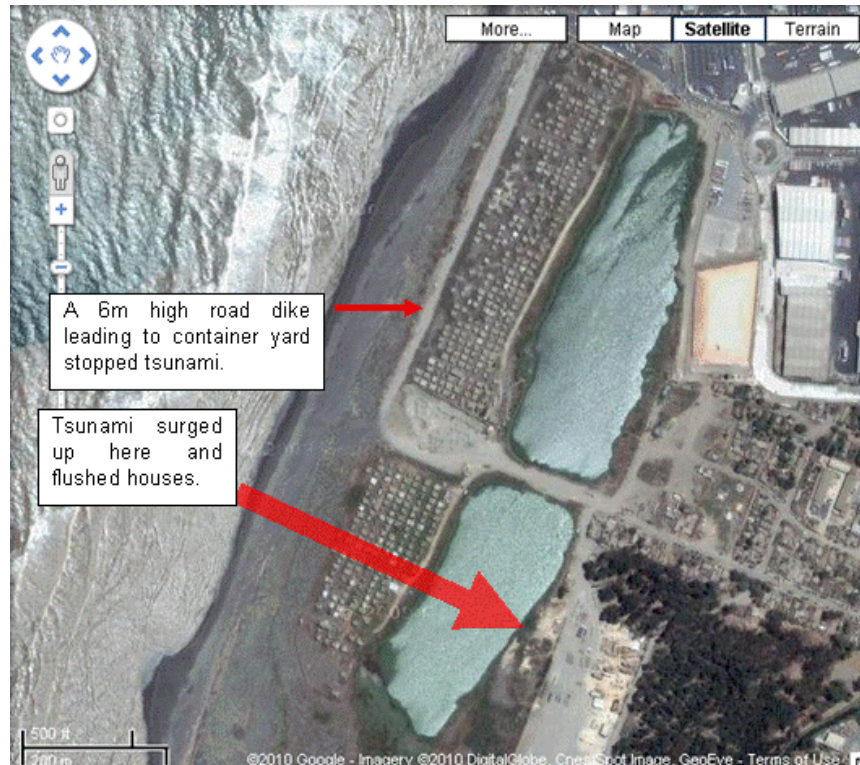
Photo 27 Tsunami protection by embankment (drawn on Google Map)

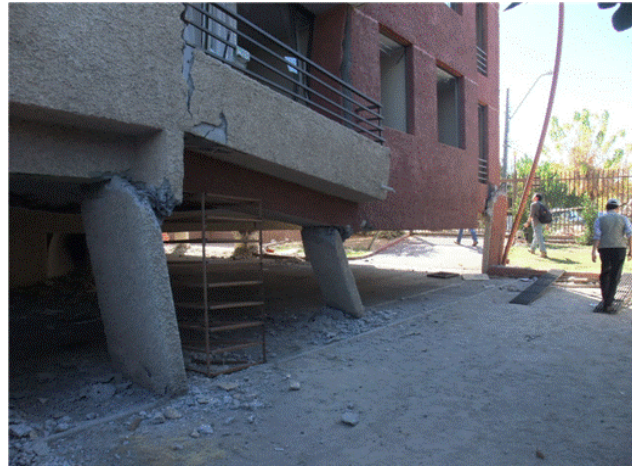
Several buildings collapsed in Santiago, Curico and Concepción. Some of them had weak pillars as shown in Photo 28. When substantial inertia force occurred in the massive superstructure, the ground floor, that consisted only of pillars without a reinforced wall, was easily destroyed. This type of structural failure has been experienced in many past earthquakes.

Photo 28 Collapsed building at Maipú in Santiago
