# Geotechnical aspects of damages in Concepción, due to the $M_w$ 8.8 Chile earthquake on February 27, 2010

2011 Pan-Am CGS  
Geotechnical Conference

Manuel J. Mendoza<sup>1</sup>, Efraín Ovando<sup>1</sup>, Felipe A. Villalobos<sup>2</sup>, Miguel Rodríguez<sup>1</sup> & Paulo Oróstegui<sup>3</sup>

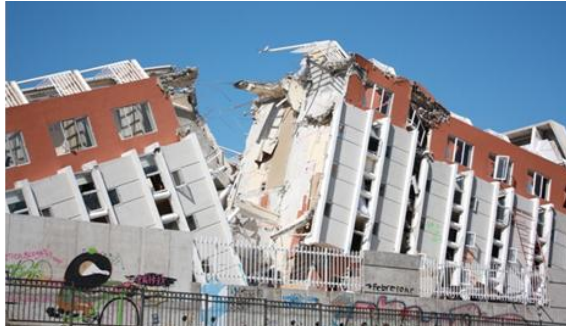
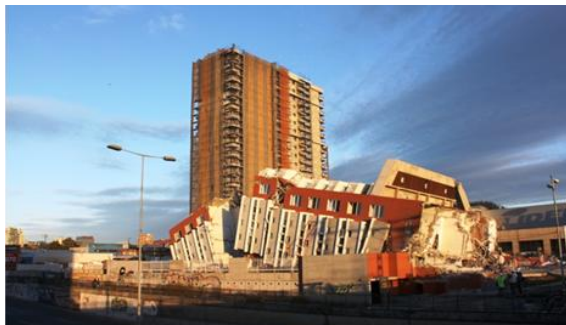
Figure 1. Overturned “Alto Río” building in Concepción.

With respect to the behavior of its foundation, the Alto Río building that completely overturned in Concepción, Fig. 1, deserves a particular review. The construction had 14 floors and two basements. Fig. 20 shows a longitudinal cut of the building, which had a floor plan proportion of length versus width of 3 to 1. The structure consisted of reinforced concrete walls, typically 20 cm thick, and floor slabs also of reinforced concrete, of 15 cm thickness. The building reached a height of approximately 40 m. The foundation was solved with a solid slab of reinforced concrete 80 cm thick in the area under the tower, set from ground level at -5.94 m, from which the concrete walls rose. In the parking area that was located behind the

The failure occurred when the vertical elements of the ground floor and/or basements collapsed, apparently from compression, on the vertical back plane opposite that of the façade, indicated with an arrow on Figs. 21 and 22. Fig. 22 shows the ground floor plan, indicating the area occupied by the building itself, and the underground parking behind it and out of its projection. Apparently, the reduction or non existence of walls along the longitudinal axis of the building's back façade, indicated with arrows, seems to have propitiated the failure by compression which, in turn, gave origin to the failure by tension of the front façade's vertical elements. The building as a whole overturned with rotation from the ground floor level, the vertical elements of the façade zone failing by tensile rupture, Fig. 23, and therefore the building fell on its back.

Regarding the participation or influence of the foundation in this mechanism, it had been speculated among some local specialists that the building's collapse was due to a foundation failure, probably caused by liquefaction of the underlying sands.

The authors had the opportunity to review the results of geotechnical soundings in which the presence of compact to very compact sand and sandy silt, not susceptible to liquefaction, were detected.

contribute to the building's overturn, because no indication that it had experimented settlement or rotation was detected. To support this, the image in Fig. 24 shows that the lateral displacements suffered by the foundation box were of very small magnitude, only 6 mm. This means that the continuous concrete wall of the basements on the façade's plane underwent very reduced displacement with respect to the surrounding ground.

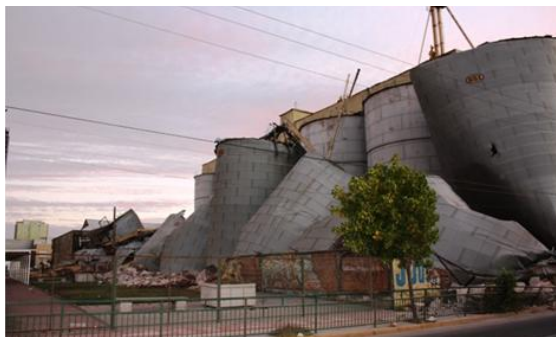
Figure 2. Silos that failed at center of Concepción.

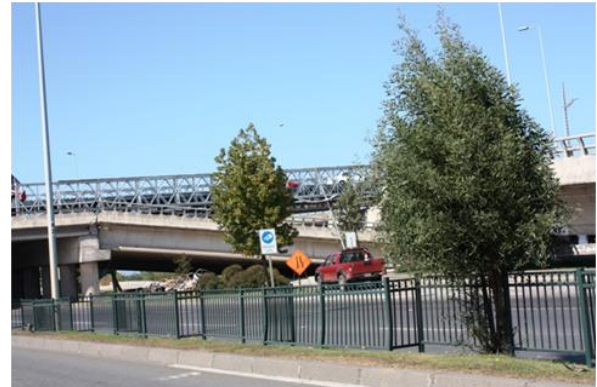
Figure 3. Provisional metal bridge over collapsed section of bridge over Bío Bío river, Concepción.

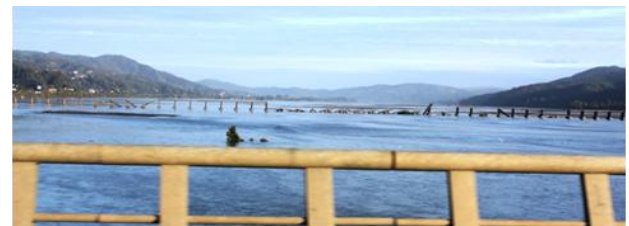
Figure 4. Multiple collapsed panels of “old” bridge over Bío Bío river.

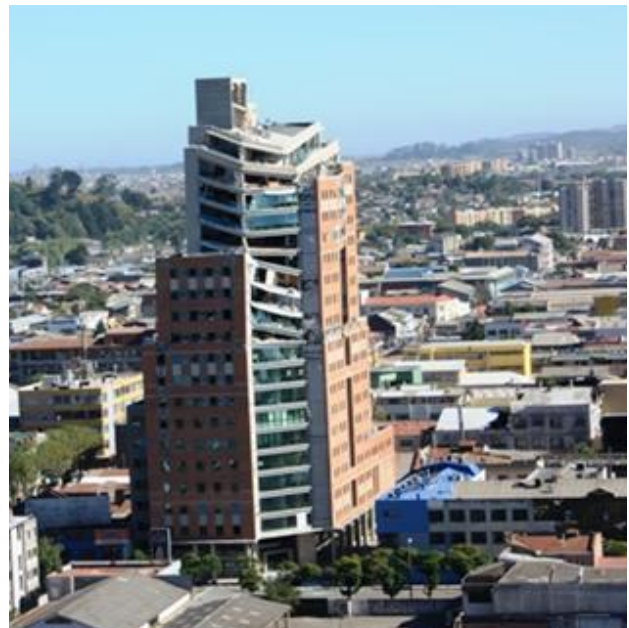
Figure 5. O’Higgins Tower, collapsed from tenth floor upwards, at Concepción.

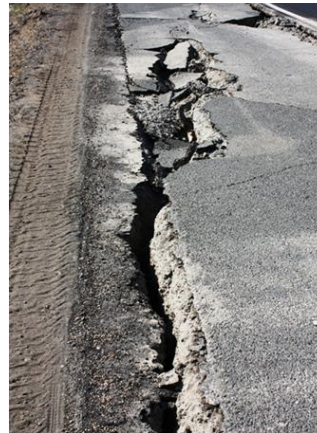
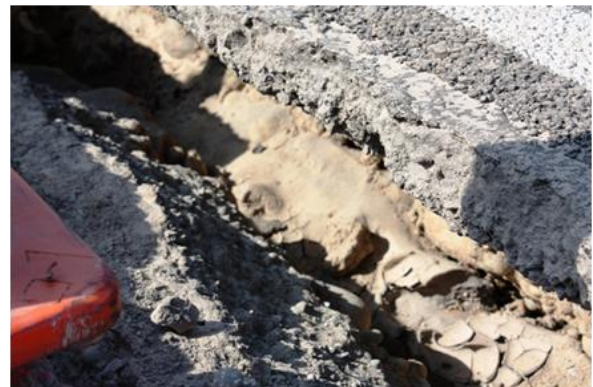
Examples of the occurrence of liquefaction on roads are shown in Fig.10, which correspond to Road 5 South from Santiago to Concepción, at the detour to Parral, some 150 km from the epicenter.

The typical pattern is the generation of longitudinal cracks tens of meters long, usually located on the shoulders of embankments no more than one meter high, or else near their middle, and on occasion at the start of slope of small embankments. Dragging, and sand at the bottom of the cracks can be distinguished.

Figure 10. Liquefaction on road 5 South, Santiago-Concepción.

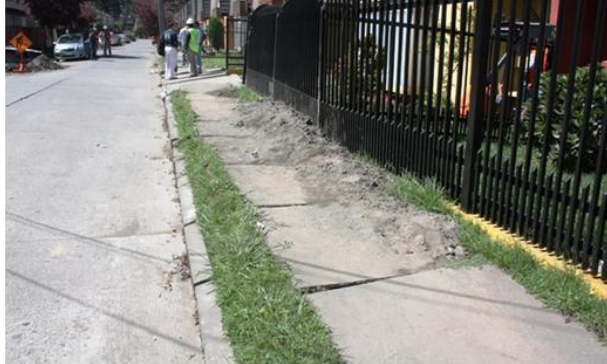
The commune of San Pedro La Paz is located south of Concepción and on the other side of the Bío Bío river. At a certain urbanization of that town profuse liquefaction of its mid size gray and uniform sands in loose state occurred, Fig. 11, to which an almost superficial phreatic level was added. The sand was dragged not only through

Figure 11. Generalized liquefaction in a group of single family homes. San Pedro La Paz.

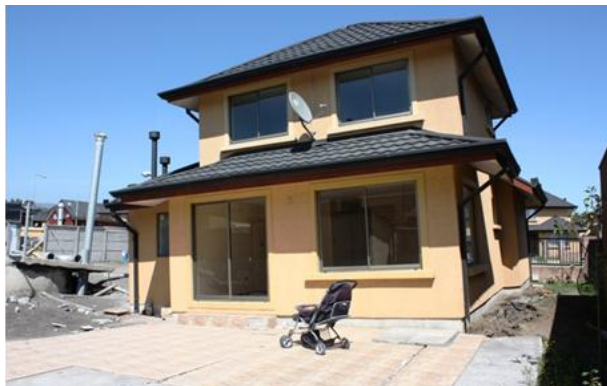
the joints of concrete slabs, but also through gardens and garages of single family homes consisting of a ground floor and a second level, causing total and differential sinking, with significant collapse in many homes, Fig. 12.

Figure 12. Heavy sinking and collapse in a single family home due to liquefaction.

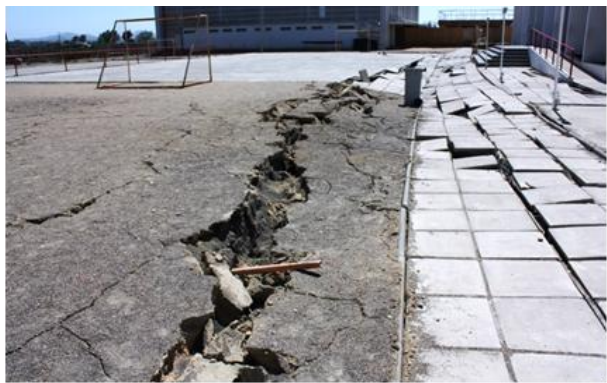
At another site of the commune of San Pedro La Paz we observed generalized liquefaction at a school of great extension and of relatively recent construction, Fig. 13. It was clear that the light brown mud-sandy surface filling had cracked and allowed the flow of water through and the loss of dark gray sand from underneath, causing settlements of up to 60 cm at the foot of the stairs visible in the photo.

Figure 13. Liquefaction at a school's patio in San Pedro La Paz.

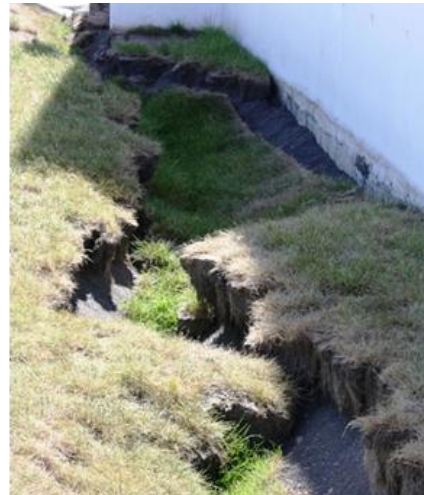
that liquefaction only occurred a few decimeters from them, developing cracks in the soil parallel to the walls of the buildings, Fig. 14. In no case we observed ground cracking “crossing” under a wall; the rigidity of the buildings contributed to their not cracking. Only in one case we observed relative movement between two bodies of buildings, which caused their fracture.

Figure 14. Cracking parallel to the school's constructions, caused by liquefaction. San Pedro La Paz.

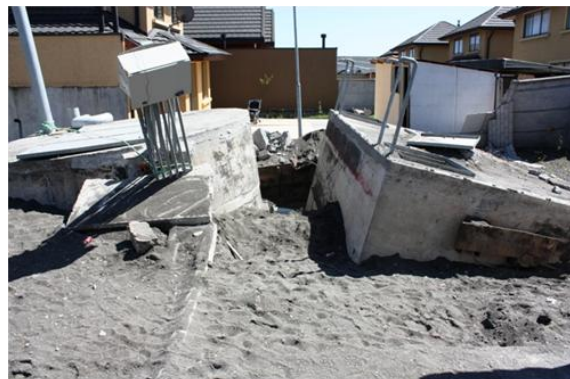
of boxes that constituted the valve room of a treatment plant, as shown in Fig. 15, as well as of an adjacent booth. As in the case of the urbanization's light homes, the weight of those boxes was not sufficient to prevent the annulment of effective strains in the sandy, saturated and loose ground, generating liquefaction and the flotation of the boxes.

Figure 15. Flotation of boxes of a treatment plant in San Pedro La Paz.

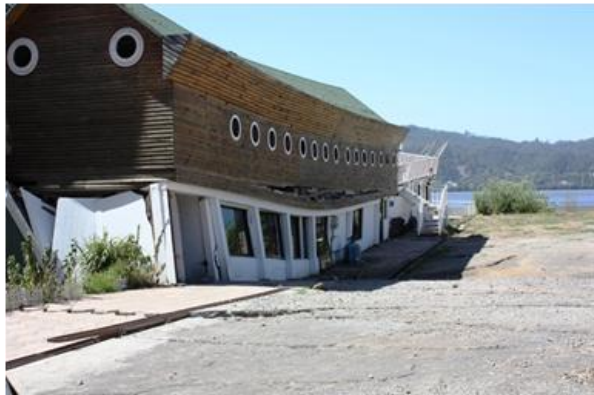
A marked crack occurred on the left bank of the Bío Bío river, land also belonging to the commune of San Pedro La Paz, on the road to Santa Juana. It developed along hundreds of meters as result of the profuse liquefaction and lateral spreading phenomena, causing multiple damage to homes and restaurants, some not yet opened, that had been built near the river's border, Fig. 16; the liquefaction phenomenon was even present on the floor inside one of the restaurants, as the result of structuring with very light materials.

Figure 16. Extended cracking on the bank of the Bío Bío river.

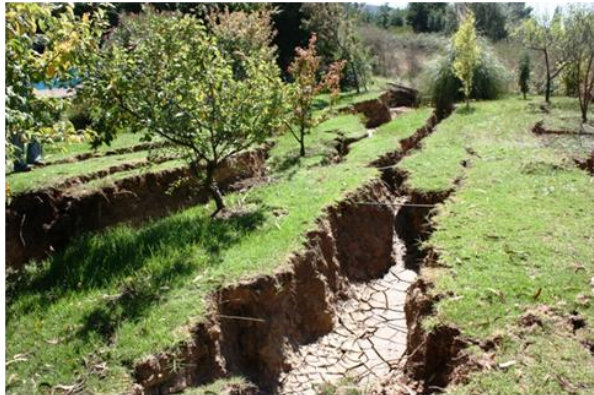
Lateral spreading was favored by the slight slope toward the plentiful river, and preceded by liquefaction; the cracks were multiple, with widths of up to a couple of meters, as shown in Fig. 17, and similar depth. These

cracks allowed us to witness directly the presence of the layer of mid size and uniform sand of dark gray color, rich in mica, that suffered liquefaction. The sand is the product of the Antuco volcano eruption, and it is located between 1.6 and 1.9 m of depth from the terrain surface, with thickness of 22 cm. We had the opportunity to take samples of the sand to determine its granulometric distribution, finding that it is located just within the zone in which technical literature has defined granulometries for liquefaction-prone soils. Over that sandy layer are sandy soils with clay matrix which upon initially encapsulating the sandy layer, propitiated the generation of high pore pressure and therefore liquefaction.

Figure 17. Liquefaction, cracking and lateral spreading on bank of Bío Bío river.

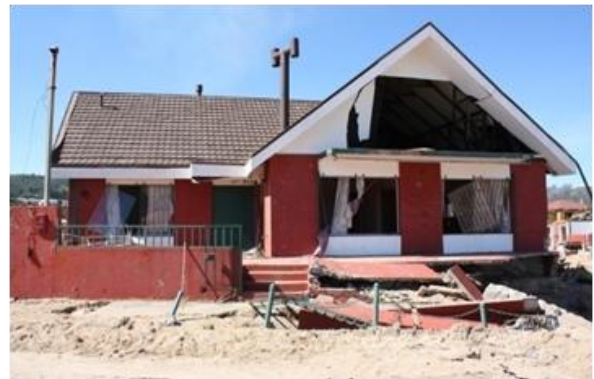
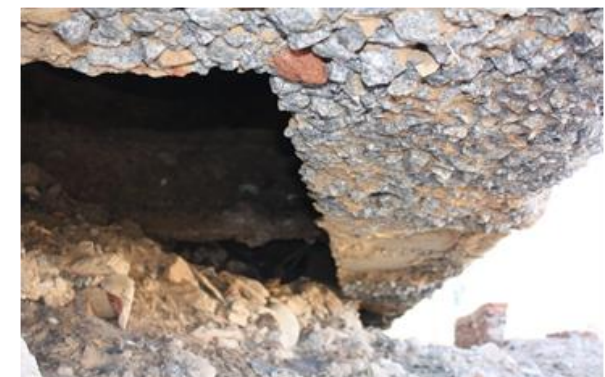
In general, the behavior of building foundations was satisfactory. It became possible to verify the virtues of a construction consisting of a robust structure supported by a continuous and resistant foundation. Figs. 18 and 19 show the conditions in which a couple of homes built a few tens of meters from the coast of Dichato were left, which suffered the onslaught of the violent tsunami that caused marked undermining. The superstructure, made of confined masonry, had no damage; only the diaphragm that constitutes the front of its roofing, and its windows, showed clear evidence that the water had flowed through them. The foundation formed by continuous footing of a

poor concrete proved capable of maintaining the structure whole and with no distortions, even though part of the footing lost its soil support.

Figure 18. Intact foundation and superstructure of a home that suffered the onslaught of the tsunami in Dichato.

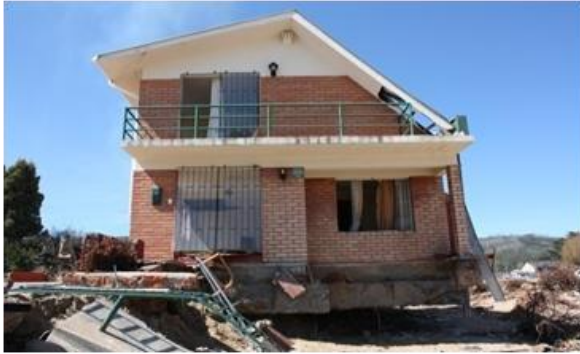
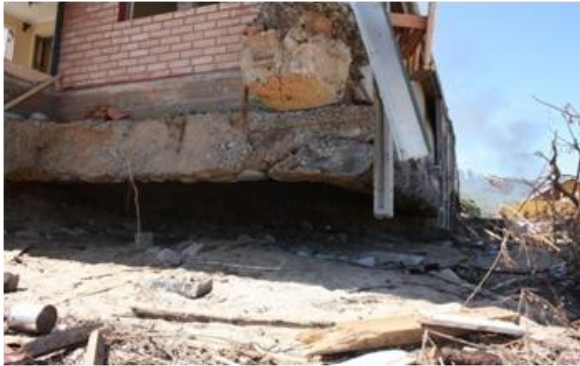
Figure 19. Intact foundation and superstructure of a house that was submitted to the tsunami in Dichato.

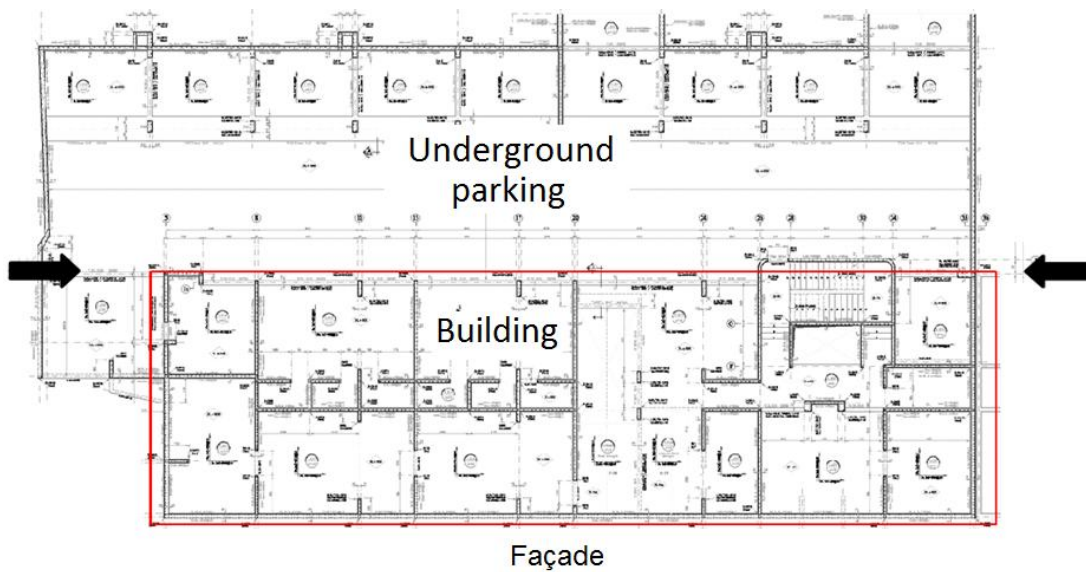
Figure 22. Plan of the first basement of the Alto Río building. Note the scarcity of vertical elements on the longitudinal axis of the building's back façade (arrows).

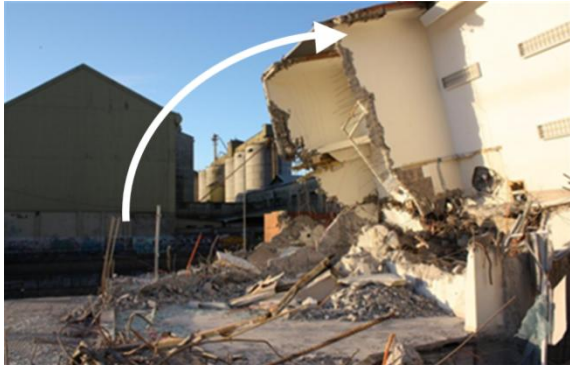
Figure 23. Final tension failure of the front portion of the ground floor, which determined the building's overturn and collapse.

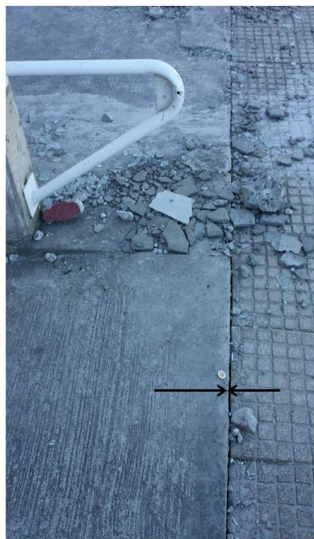
Figure 24. Lateral displacement of the foundation box of only 6 mm.

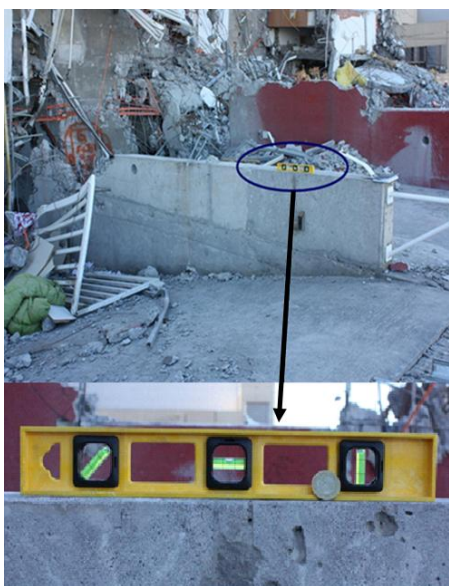
Another image that supports the foundation's practical immobility is included in Fig. 25. The bubble is completely level when placing the level on a low wall on the ground floor, indicating that the foundation did not suffer permanent angular distortions. In summary, when the building suffered its overturn, its vertical support elements failed at ground floor level, with the foundation box completely remaining in its original position, with no rotation and with only minuscule lateral displacement.

Figure 25. Low wall on ground floor totally level after the building's collapse.
