DAMAGES OBSERVED IN THE 2010 CONCEPCIÓN EARTHQUAKE RELATED TO SOIL PHENOMENA

Felipe Villalobos¹, Efraín Ovando², Manuel Mendoza³ and Paulo Oróstegui⁴

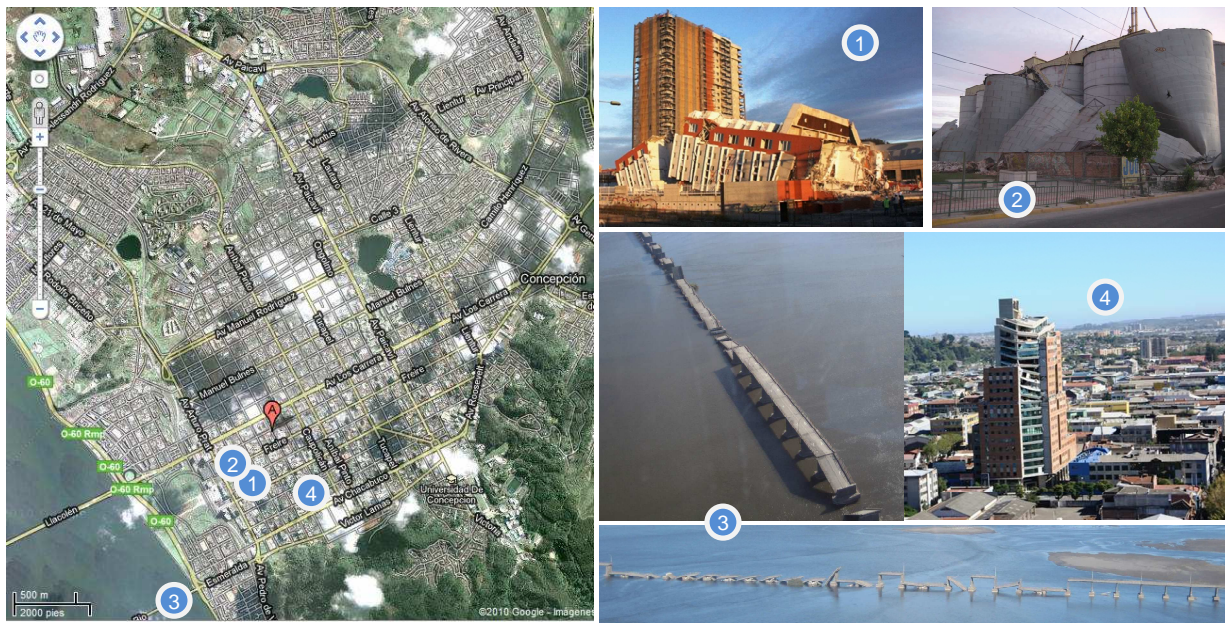
In Figure 2 circles with numbers indicate the place of collapsed structures. It has been tempting to directly blame the subsoil as the main reason of these and other failures. Circle 1 refers to the apartment building Alto Río, a two years old reinforced concrete building of 12 to 15 floors and two basements, 3:1 length and width ratio in plant, walls and slab thickness of 20 cm and 15 cm respectively. This building corresponded to the first of four similar but not attached buildings projected in this corner. The building is founded on a reinforced concrete box (the two basements), through which loads are transfer to the subsoil by a 80 cm thick slab 6 m below the surface. From the slab the building columns, shear and retaining walls arise. The soil profile consists of medium to dense Bío Bío sand deposits with layers of soft silt, having a water table from 3 to 4 m deep. Particular concern was the presence of two non plastic silt layers between 9 to 11 m deep and between 12 to 17 m deep, with values of deformation modulus E_u of 20 MPa and 30 MPa and undrained shear resistance s_u of 150 kPa and 300 kPa respectively. These values were obtained from undrained triaxial tests after applying 30 loading cycles with a constant deviator stress of 90 kPa and confining stress of 130 kPa. The silt samples underwent excess pore pressures of no more than 95 kPa accumulated at the end of the cyclic loading. No stiffness degradation was found hence no liquefaction occurrence (Petrus 2006).

Figure 2: Satellite view of Concepción showing location and pictures of collapsed structures

Circle 2 corresponds to two rows of wheat silos located to less than 100 m from Alto Río building. For that reason soil profiles and conditions can be assume as similar as in Alto Río. The first row of silos was built in the 50's and did not present damage (Figure 2b). The second row was built during the 70's and collapsed due to the failure of bolts connecting the steel silos to the footings. According to witnesses full silos burst at the based spreading wheat. The shaking densified the granular content increasing vertical stresses and therefore radial stresses as well at the base, stresses which the silo steel shell could not withstand. The authors did not find any evidence of soil failure mechanism in situ.

Circle 3 shows the old Bío Bío Bridge built during the 40s and also collapsing in the 1960 earthquake (Steinbrugge and Flores 1963; Duke and Leeds 1963). In the 60's only a couple of piers failed on the Concepción side. Due to lack of maintenance the bridge was abandoned and hence without use since 2003. In the 2010 earthquake a generalised domino effect of pier failure occurred not only on the Concepción side but also on the San Pedro de la Paz and in the middle of the bridge. It is not clear whether the bridge timber pile foundations failed or not due to, for instance, liquefaction. Liquefaction was observed downstream in the river sand banks. It has been speculated that geological faults run along the river and also cross the river exactly there, because the Caracol hill would continue on the other side in San Pedro de la Paz. Therefore, geological studies are required in the form of geophysics and gravimetric analysis for example.

Circle 4 represents the collapse of the top 10 floors of the 21 floors O'Higgins Tower. Between the 11th and the 12th floor a discontinuity in the structure triggered the collapse of structural members which in turn failed the building upwards. The authors did not find any evidence of soil failure around the tower.

Further studies need to be pursued to whether these collapses are purely related to deficiencies in structural design and construction materials and methods or there are geological and geotechnical issues such as acceleration and displacement amplification due to for example soft soil layers just under these particular sites.

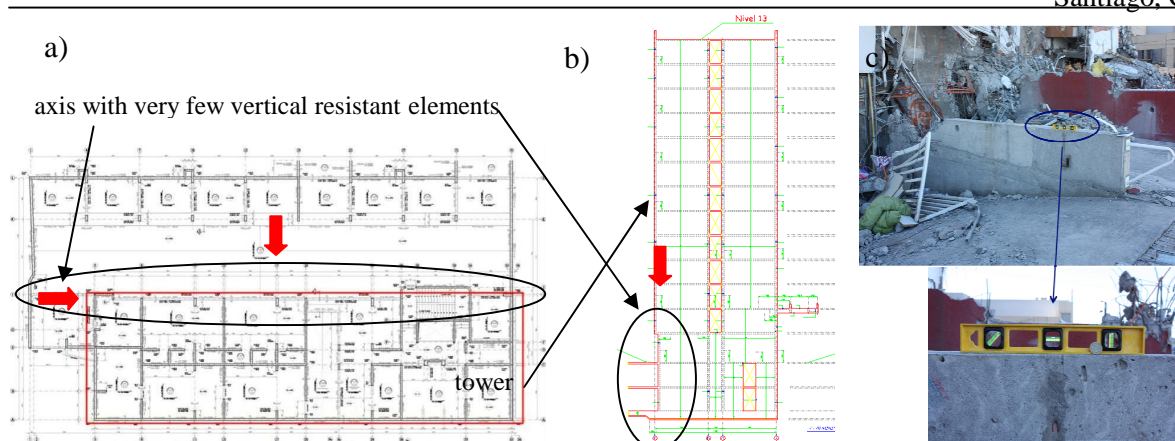
It is worth mentioning that the tower had a significant eccentricity respect to the basement since the basement extends backwards beyond the boundaries in plant of the tower (Figures 3a and 3b). Openings through the walls allowed the access to the extending basement area (Figure 3b). This gave origin to a weak line exactly at the back of the building. Witnesses indicate that the tower swung torsionally and then sunk at the back and finally the columns and shear walls in the front line were cut at the ground level to fall backwards completely after no more than 30 s from the beginning of the earthquake. The authors inspected the site and could not find serious evidence of settlement, lateral displacement (6 mm), rotation or any bulge indicating the development of a soil failure mechanisms, nor evidence of liquefaction or geological fault. Nevertheless, studies of amplification need to be carried out to find out whether accelerations and deformations were particularly high due to the presence of the soft silt layers.

Figure 3: Alto Río a) tower in an eccentric position respect to the whole basement, b) openings at the back where failure may have started and c) base without tilting

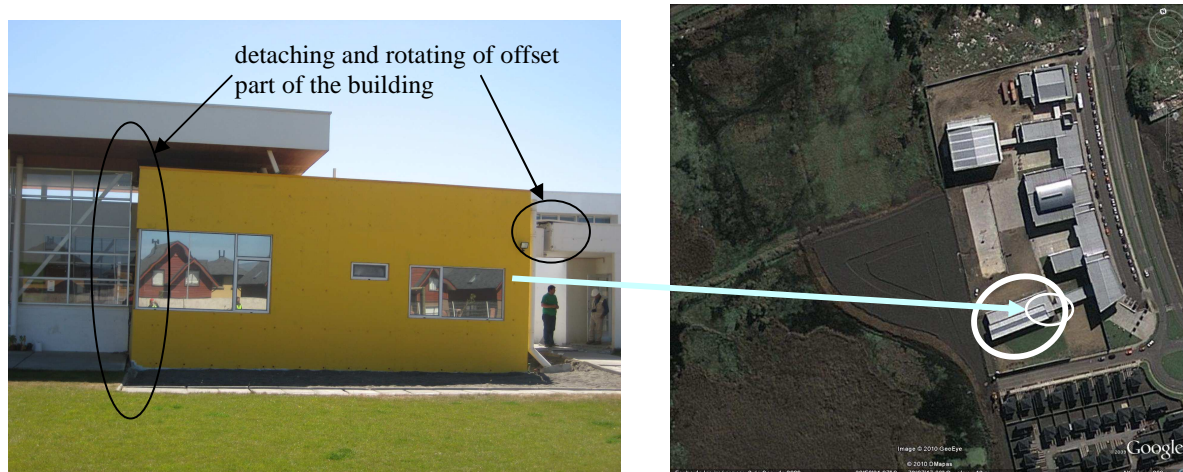
The school of San Ignacio in San Pedro de la Paz, with the same subsoil of Los Batros swamp did not suffered noticeable damage in its new facilities except ground settlements around playgrounds up to 60

cm and in an isolated one floor building, close to the swamp (see Figure 5). This rectangular reinforced concrete building of 15 m wide and 40 m long is founded on shallow footings 1.1 m below the surface with the water table between 1 and 2 m deep. Soil mechanics studies indicated that the subsoil had too poor quality to found the school. Therefore, a soil improvement was considered by using biaxial geogrids and geotextiles under compacted 80% relative density clean Bío Bío sand of 3 m thickness below the foundation level to replace a compressible silt (Sepúlveda, 2006). The only building with structural damage had to cope with ground displacement towards the swamp. The damage concentrated in a singularity of the building architecture, which could not keep the ground movement. This singularity corresponds to a separated room slightly offset from the rest of the structure, with a different roof level and on one side without solid structural connections with the main structure. As a consequence this room tilted 4°, hence openings cracks of 10 cm wide on the floor and detaching from the roof and windows. It is worth mentioning that the authors are not aware to whether the geosynthetic solution was applied on the whole area or only under some facilities. In the light of the observed cracks in the soil and in the building, it is believed that a confinement deficiency occurred towards the swamp. A natural slope exists towards the swamp and despite the compacted and reinforced sand fill, the land level at this point is approximately 1 m lower than for rest of the area. Possible solutions are to build a retaining structure or to extend the ground improvement further than the existing 8 m to the swamp.

Figure 5: San Ignacio School, San Pedro de la Paz showing where damage was concentrated

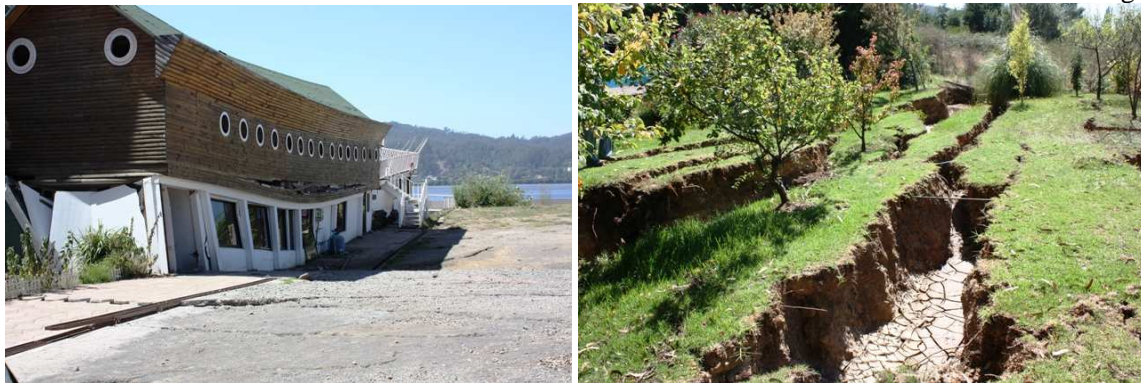
Striking crack patterns were observed along the Bío Bío River south bank also in San Pedro de la Paz, along the road to Santa Juana. Along hundreds of meters these cracks developed parallel to the river, causing serious damage to structures. A cross section sketch would show hills of 100 m on one side of the road and then a narrow land ending into the river. This narrow piece of land (50 to 100 m wide) has been reclaimed mostly with material from the hill and also from the river to avoid flooding. The authors are not aware of any type of soil improvement carried out to reclaimed ground, except under the road and under some structures closer to the road. Ground movement towards the river was considerable, destroying restaurants, houses, swimming pools, piping and gardens (Figure 6). It is believed that liquefaction occurred in deposits of saturated and loose sand below 2 and 3 m from the surface, at the level of the river (Figure 7). Above that level, reclaimed ground slid on the liquefied sand towards the river. Sand deposits were trapped, unable to dissipate excess pore pressures, since reclaimed grounds were residual soils from weathered rocks in the form of silt and clay material. Some cracks closer to the river had depths of 2 m and 1 m wide. Without intensive improvement of the natural soil deposited by the river and the soil fill deposited by the man it is not recommended to found structures, otherwise large soil displacements occur due to lateral spreading.

Figure 6: Damage in a restaurant, garden and piping due to lateral spreading along Santa Juana road

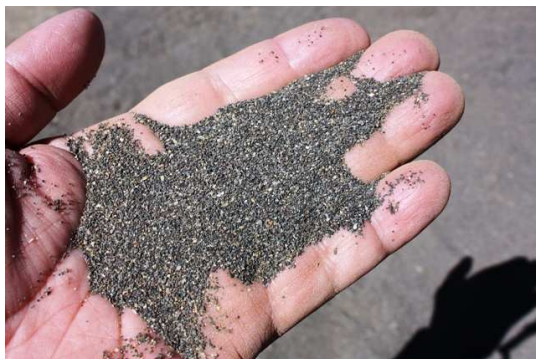
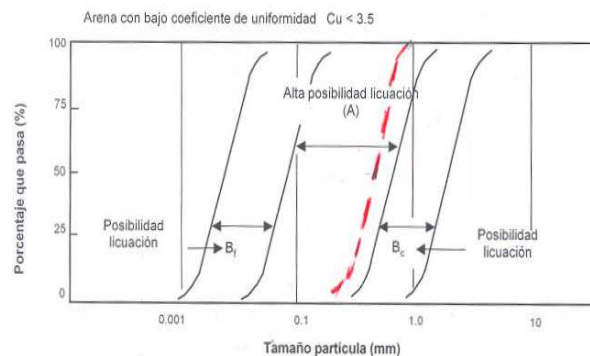
Figure 7: Sand found at crack bottom with grain size distribution inside highly liquefiable range

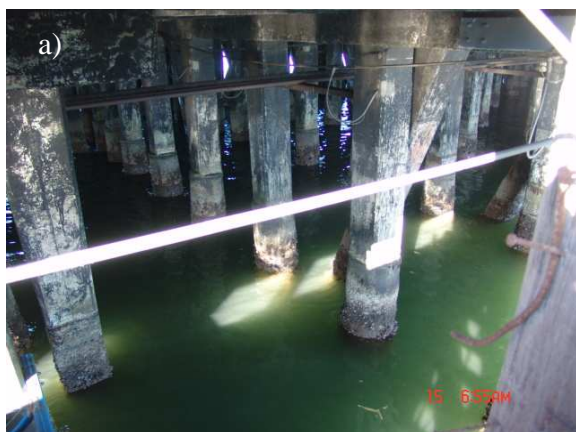
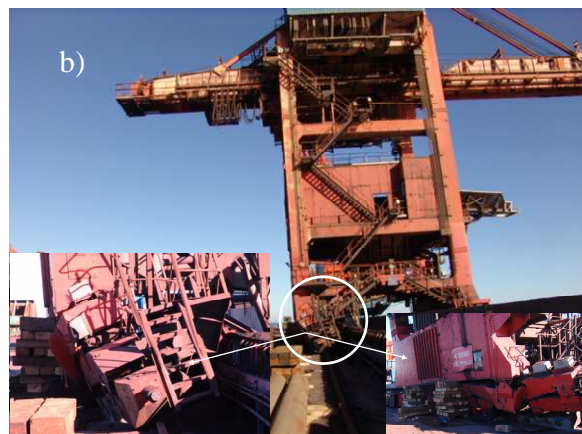
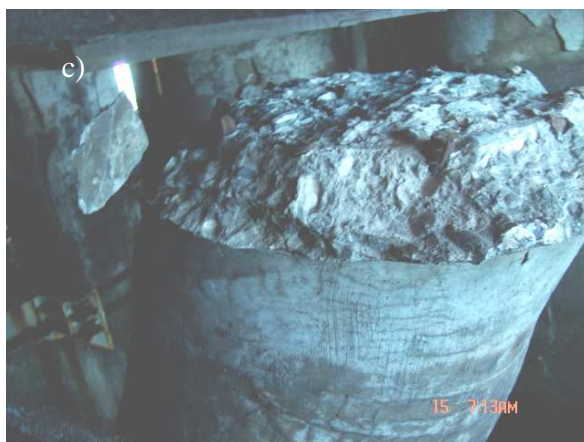
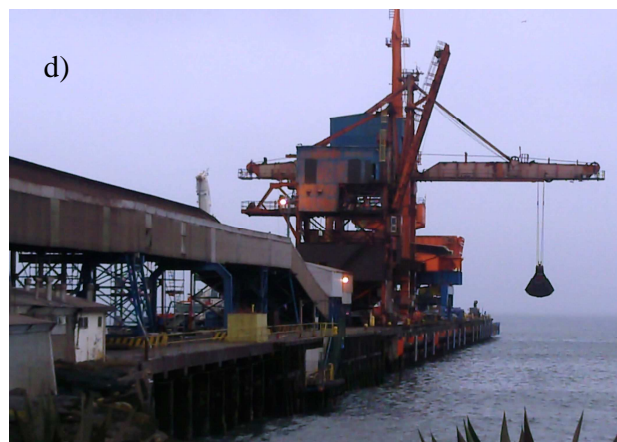
The plant's wharf was built in 1945 and extended in 1972 to the current 400 m long. The first part is founded on pre-concreted piles of 50 cm square section and reaching depths between 15 and 18 m. There is a high pile density including inclined piles to resist horizontal loads (Figure 8a). The 1972 extension rests on driven steel tubular piles 457 mm diameter and 20 mm thickness and filled with in situ poured concrete. Additionally, these piles have an external annular concrete cover of 25 mm thickness where 12 mm steel bars were in contact along the steel tube becoming pile reinforcement as well (Figure 8c).

In the wharf's access embankment settlements and lateral displacements were observed in the form of a step. Apparently pre-cast concrete piles of the 1945 part did not experience damage, although it was discovered that reinforcing elements inside the piles are in an advanced state of corrosion since they crumble easily when touched by hand. Therefore it is necessary to repair or replace as soon as possible corroded steel elements which reduce the structure resistance. In addition, several pile caps of the 1972 extension failed and a portal crane on the wharf's platform tilted because wheels on one side derailed. In these peculiarly designed piles, the welded connections to the platform were cut. These joints require stronger connection elements to withstand large seismic forces transmitted back and forth from the piles to the platform. It is not recommended to joint two stiff and heavy elements (group of piles with the platform) without a well reinforced pile cap.

Figure 8: a) Piled foundation of the wharf, b) portal crane derailed, c) pile cap broken in wharf extension and d) wharf general view

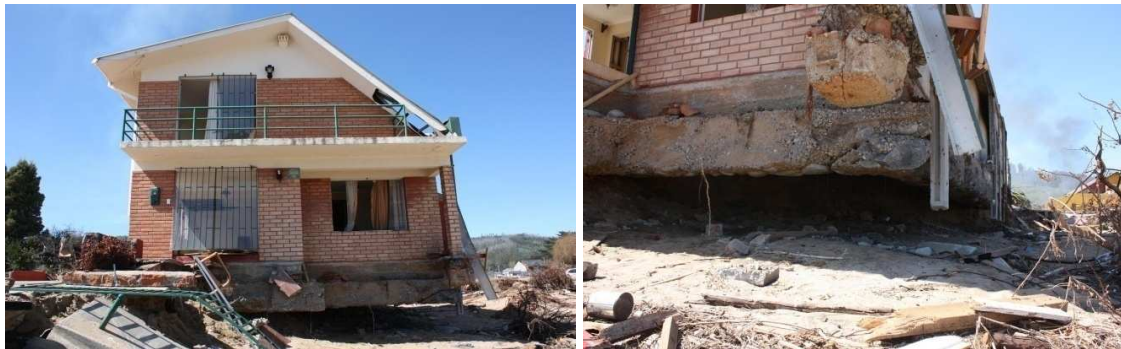
After the earthquake there was a series of tsunamis flooding some parts of the coastal area depending on the position and distance respect to the epicenter, bathymetry and topography. The seaside town of Dichato was one of the most devastated places along the coast. Several waves swept away the lower parts of the town hitting the front and the back of the town because waves entered through a stream. Dichato is located 9 km north of Tomé in the close and small bay of Coliumo. The bay shape probably caused intense rebound of currents. The few houses standing after the tsunami were made of reinforced concrete or bricks or a mixed of both. However, the authors noticed that standing houses in front of the shore had part of their foundations exposed. The tsunami attacked four or five times according to witnesses being the third and last wave the highest. High velocities and therefore large drag forces were imposed by the tsunami current when arriving as well as when retreating. The tsunami strong currents scoured the footing of the few standing houses. Figure 9 shows a house in cantilever, resting on one side since the other side was removed by tsunami currents. It is worth remembering that this house resisted a strong earthquake and a devastating tsunami. For future constructions on the shore it should be considered structures in addition to earthquake and tsunami resistant also the effect of scour. This phenomenon form normally part of bridge design for example or in structures under strong sea or river currents. A possible solution is to deepen the foundation to a depth where scour does not remove the foundation soil. The scour needs to be calculated with hydraulics methods.

Figure 9: A house in Dichato with foundation exposed due to scour by tsunami
