# Preliminary analysis of the seismic response of bridges during the Chilean 27 February 2010 earthquake

Análisis preliminar del comportamiento sísmico de puentes durante el terremoto chileno del 27 de febrero del 2010

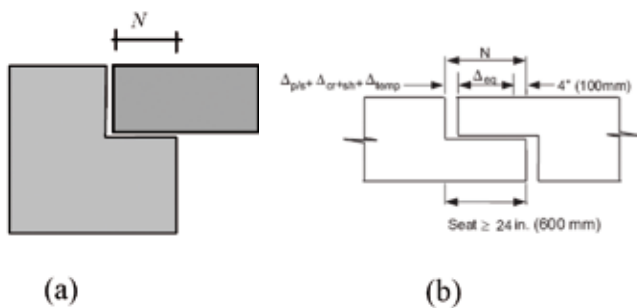
Figure 1: Definition of the seat width  $N$  a) *Manual de Carreteras* (2002) and b) Caltrans (2006)

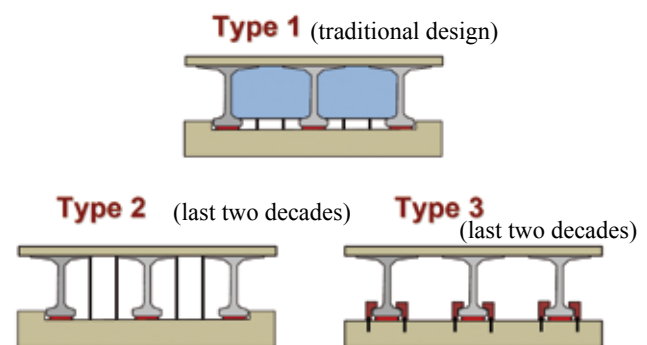
Figure 2: Types of superstructure configurations

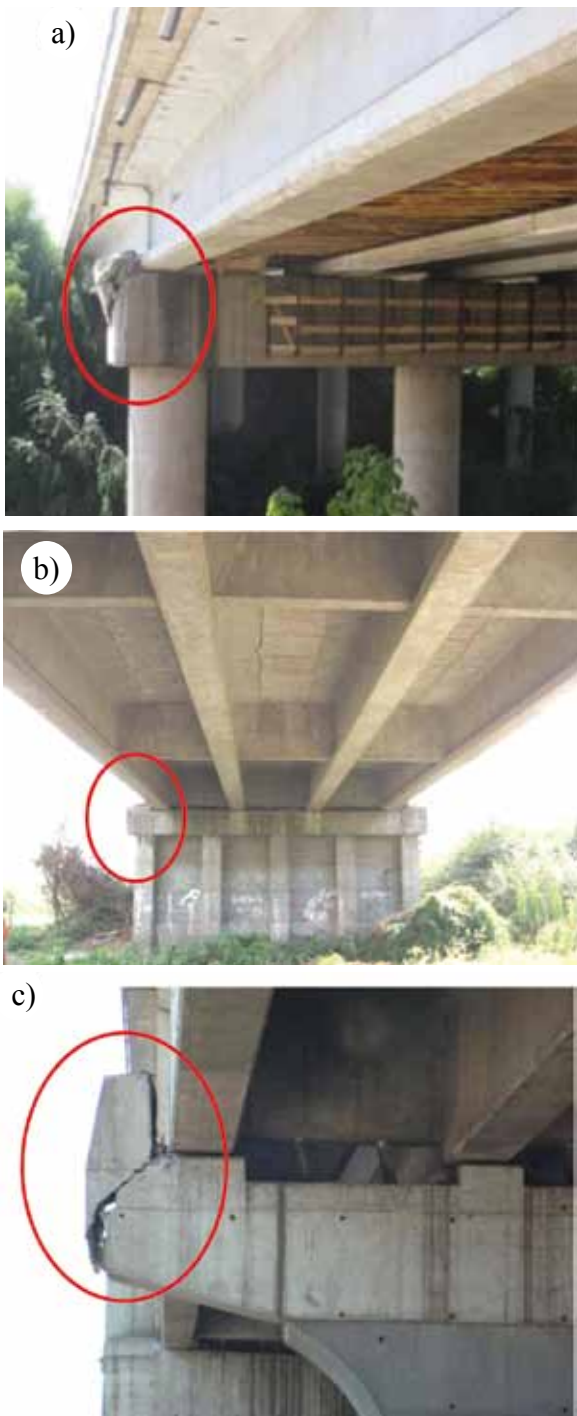
Figure 3: Damage in bridges of type 1 configuration: a) Costanera Norte, b) Lollole and c) Vespucio Norte at Independencia

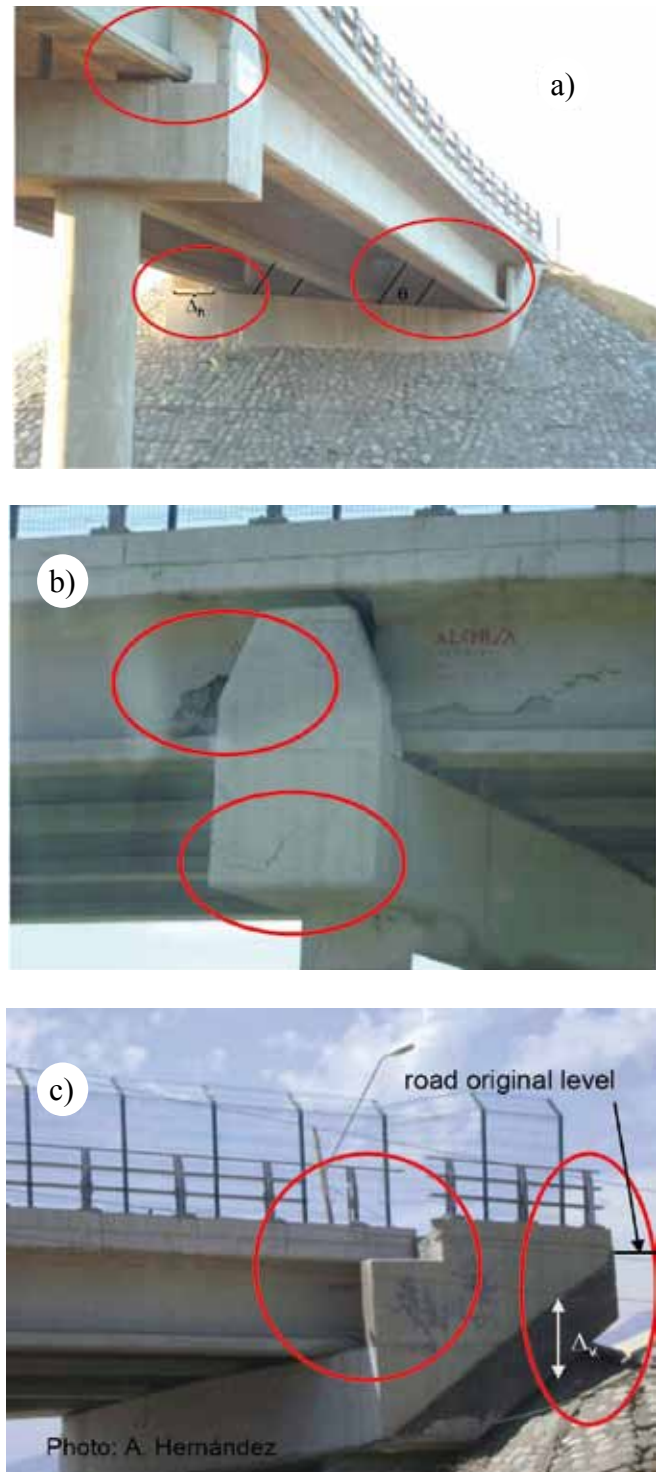
Figure 4: a) and b) Damage in bridge of type 2 configuration, underpass Azufradero, and c) embankment settlement in underpass Chada.

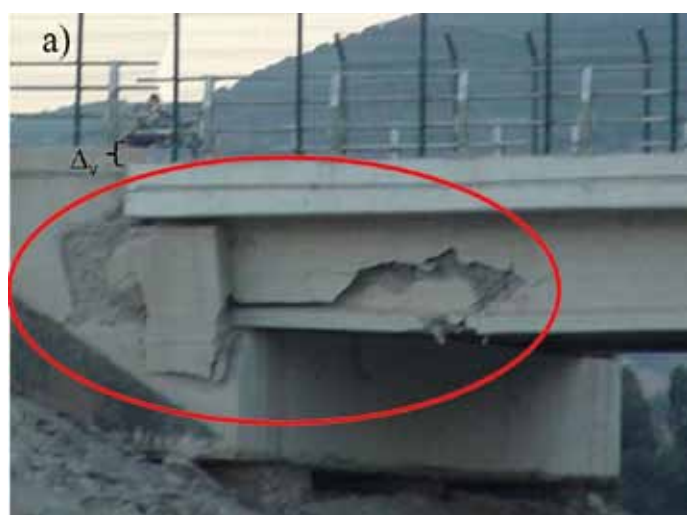
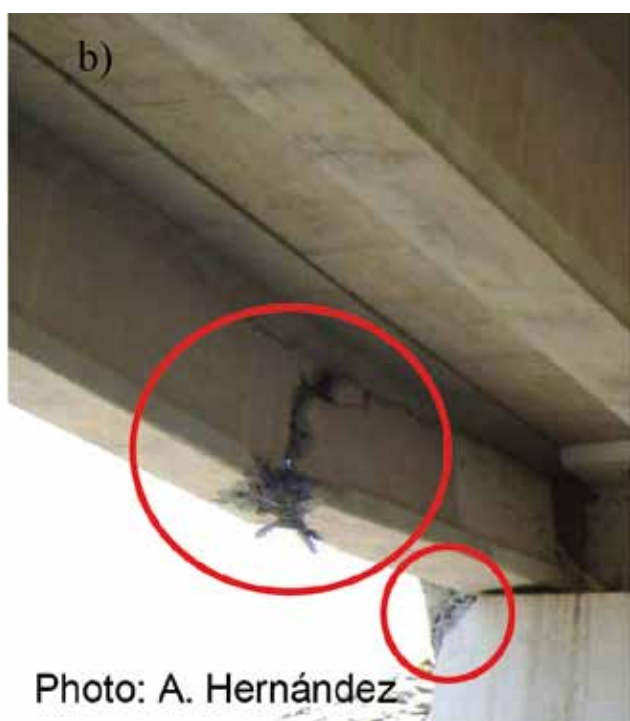
Figure 5: Damage in girders of type 2 bridge configuration, underpass Chada, South access to Santiago.

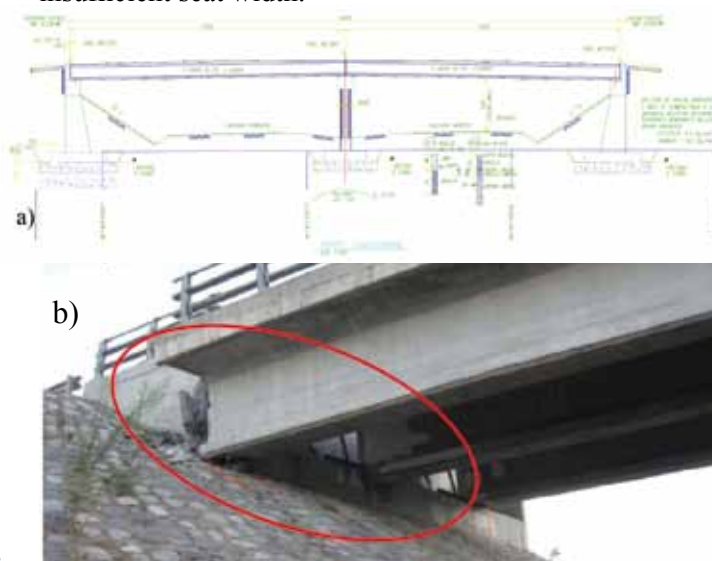
Figure 6: Damage in Las Mercedes underpass, bypass Rancagua, route 5.

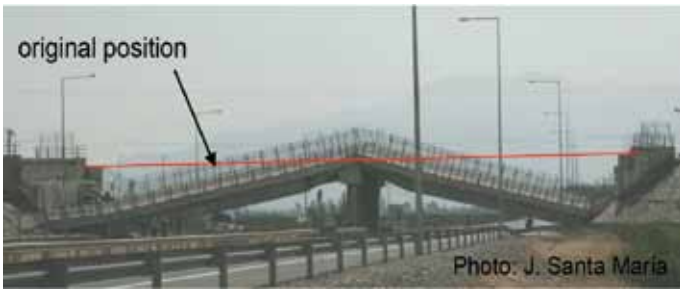
Figure 7: Collapse of Los Pinos underpass, South access to Santiago.

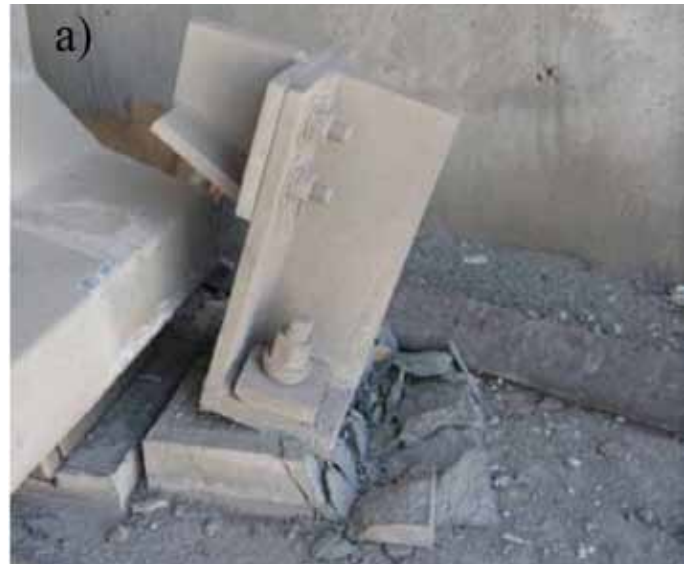
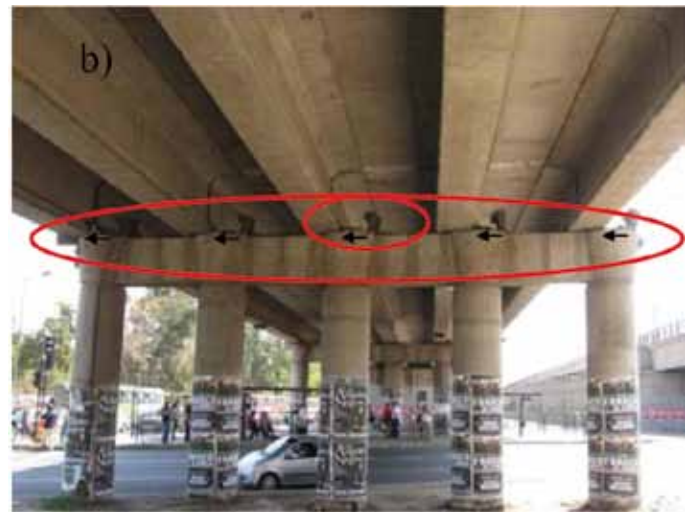
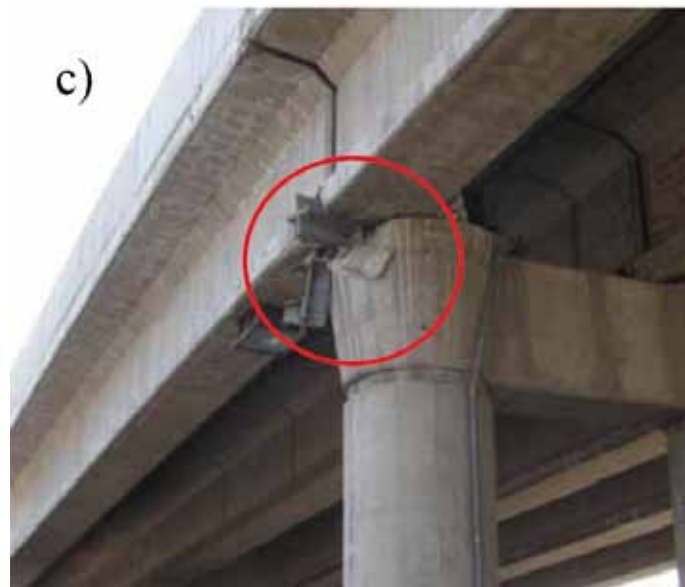
Figure 8: Damage in bridges of type 3 configuration: a) shear key failure detail b) and c) lateral displacement of girders in Vespucio Norte at Independencia.

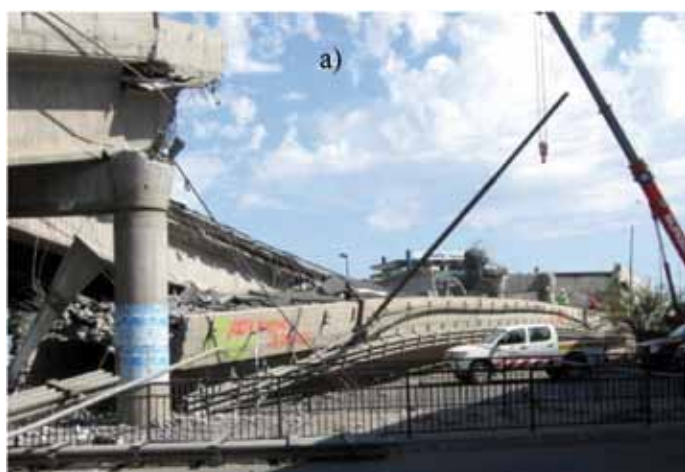
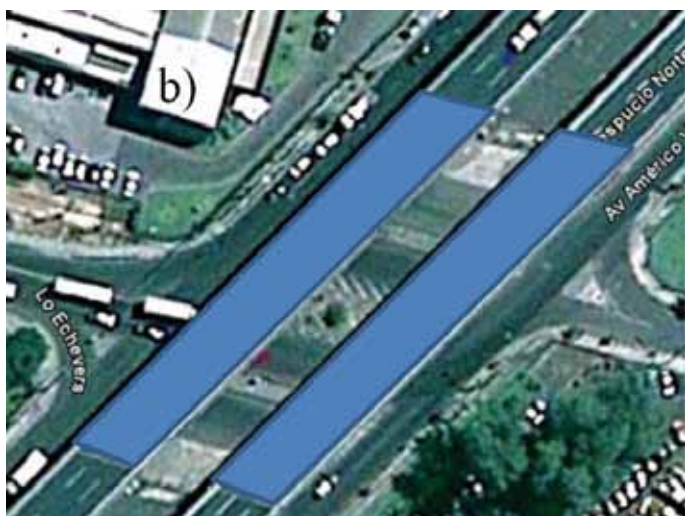
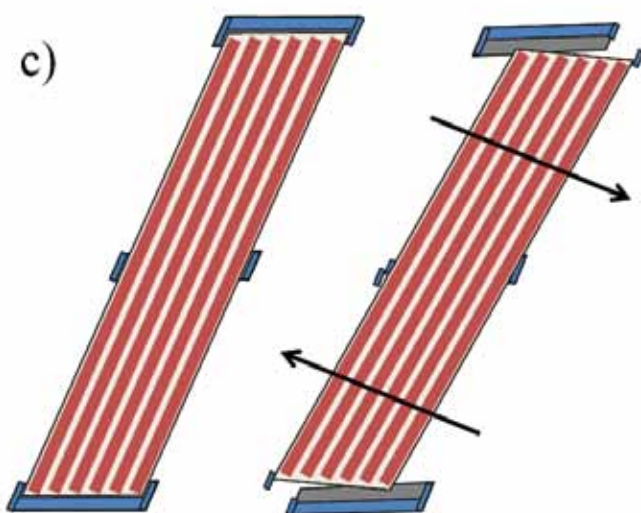
Figure 9: Lo Echeverría junction a) bridge collapse, b) plan of skewed bridges and c) deck rotation

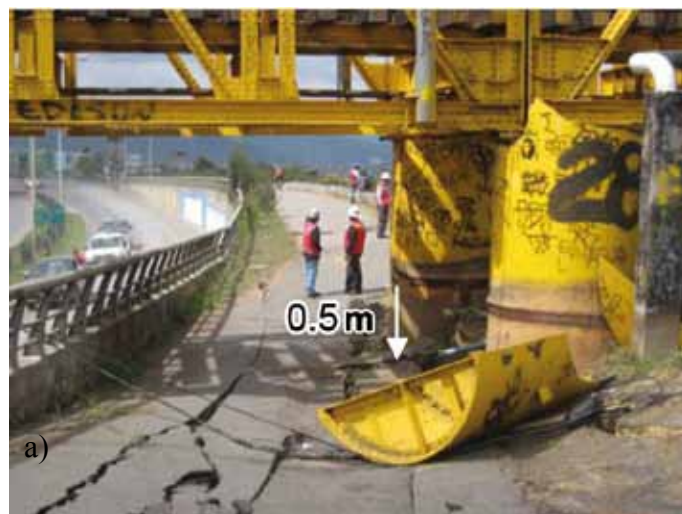
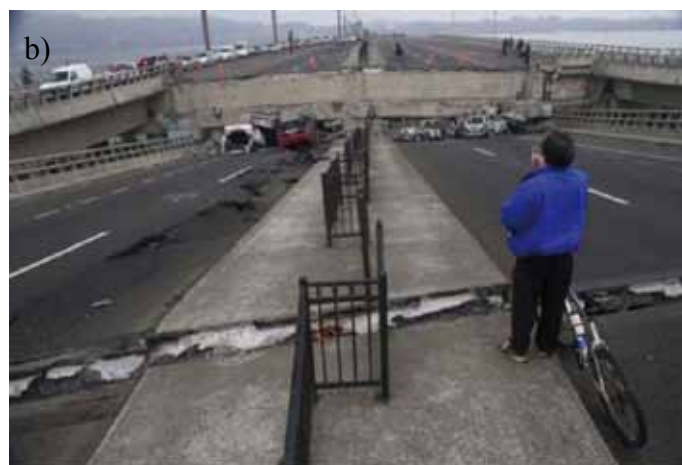
Figure 10: a) Abutment settlement and lateral displacement in Concepción railway bridge and b) collapse in the access to the Llacolén bridge in the Concepción side

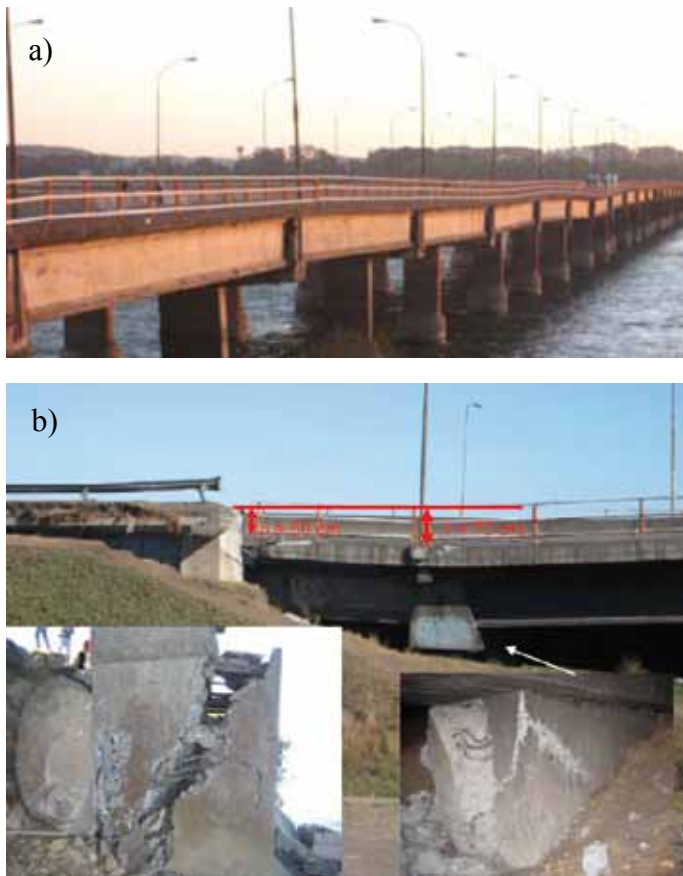
Figure 11: Juan Pablo II Bridge showing a) unevenness due to pier differential settlements and b) shear failure in reinforced concrete piers

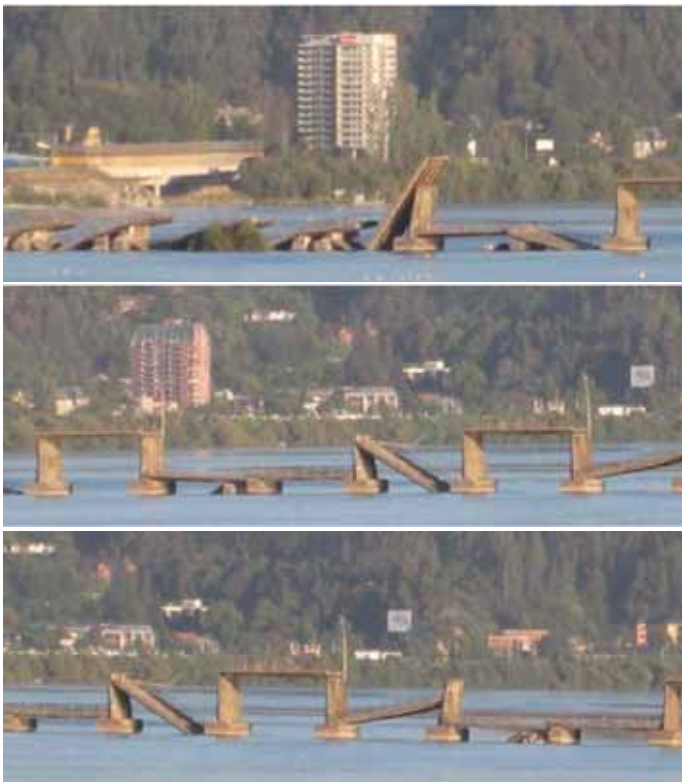
Figure 12: Sections collapsed of the Bío Bío Old Bridge
