CRUSTAL DEFORMATION ASSOCIATED WITH THE 1960 EARTHQUAKE EVENTS IN THE SOUTH OF CHILE

Felipe Villalobos

Lecturer, Dept. of Civil Engineering, Catholic University of Concepción, Chile,
avillalobos@ucsc.cl

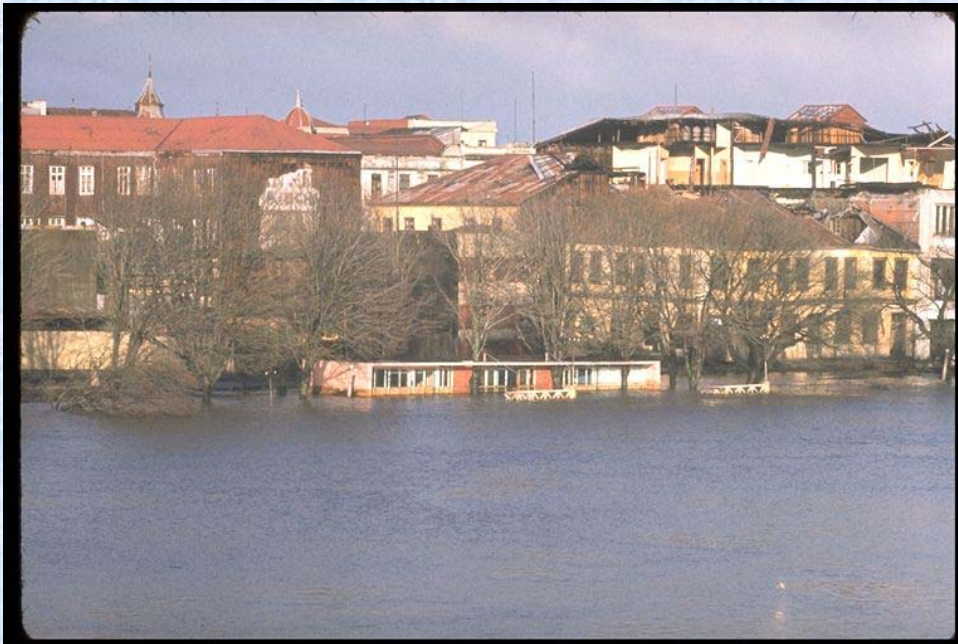
Several weeks
after 22/05/1960
Steinbrugge and
Flores (1963)

Despite the epicentre was in Arauco, Valdivia was the most affected area

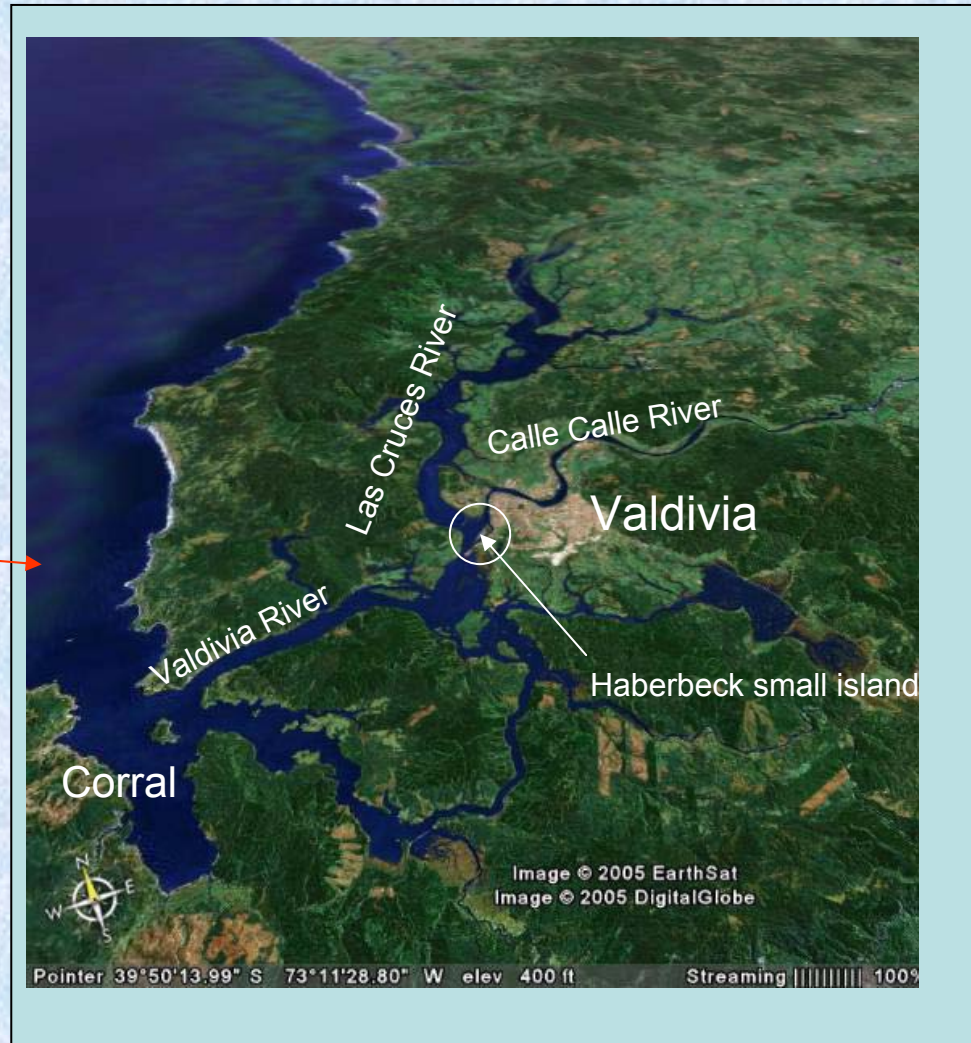
Valdivia city and surroundings

★ Possible epicentre positions

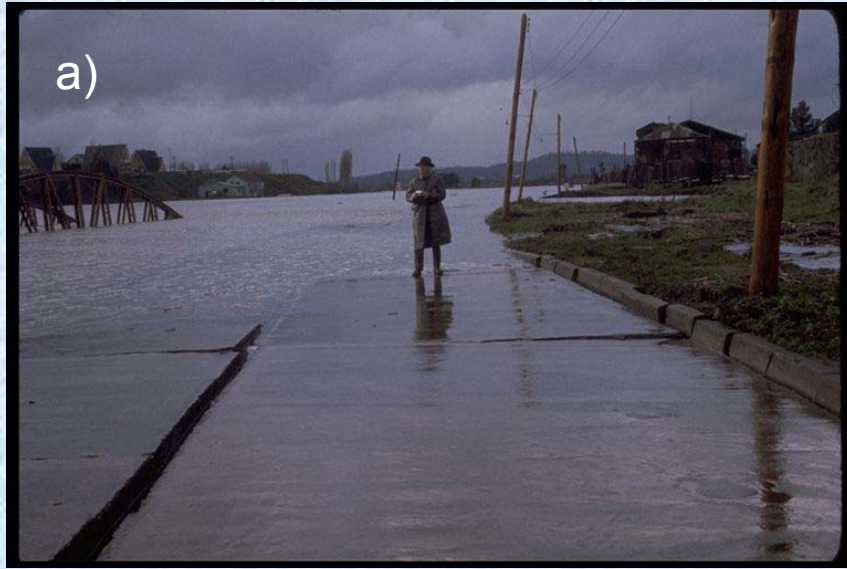
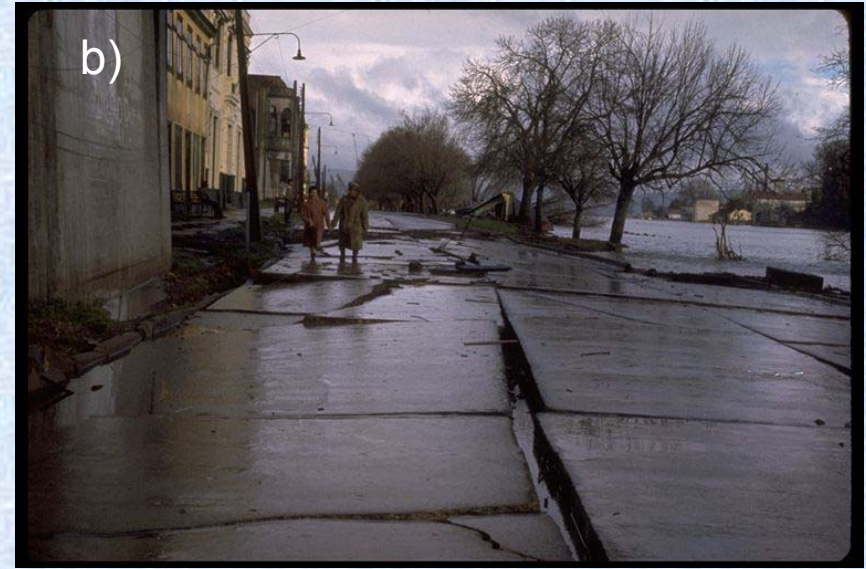
Subsidence along the Valdivia promenade

Road along the promenade showing concrete pavement distorted, broken and tilted towards the river, (a) road going under the river passing the bridge in the upstream direction and (b) just before passing under the Pedro de Valdivia Bridge.

Waterfront dropped about 2 m due to regional subsidence.

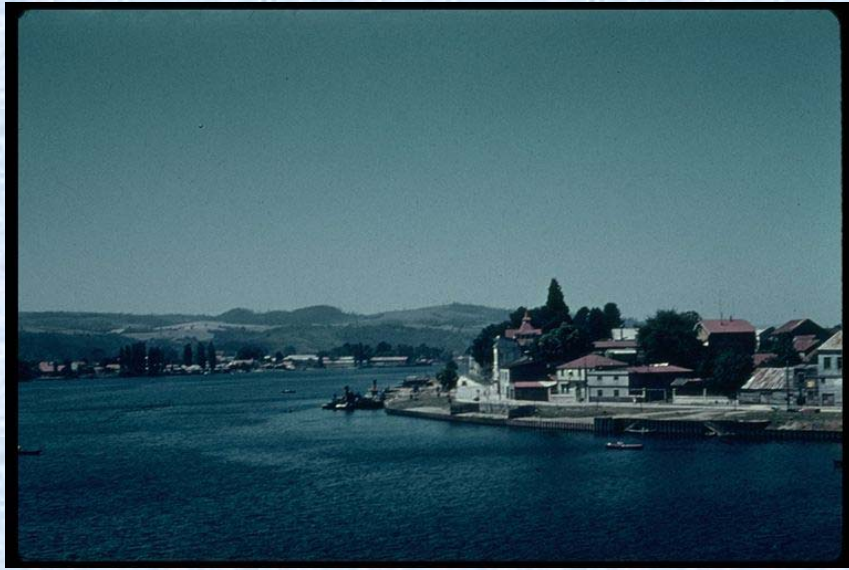
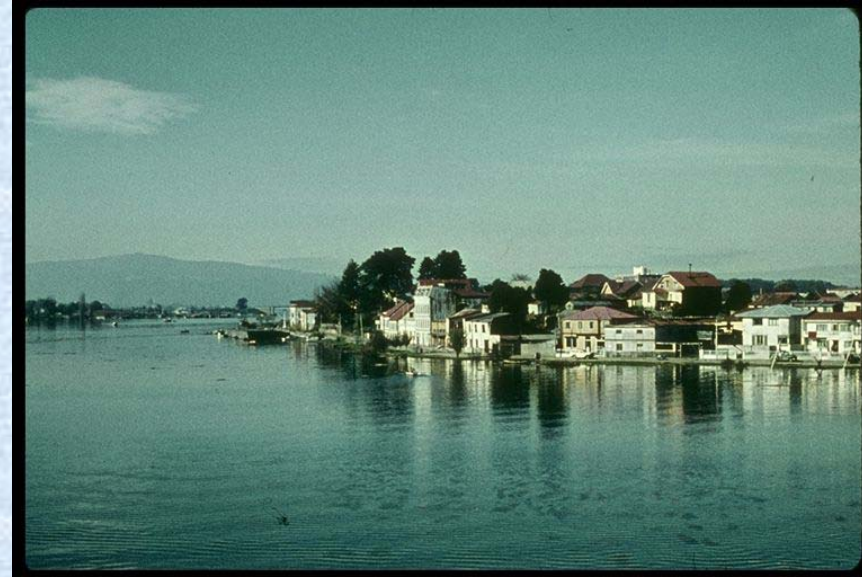
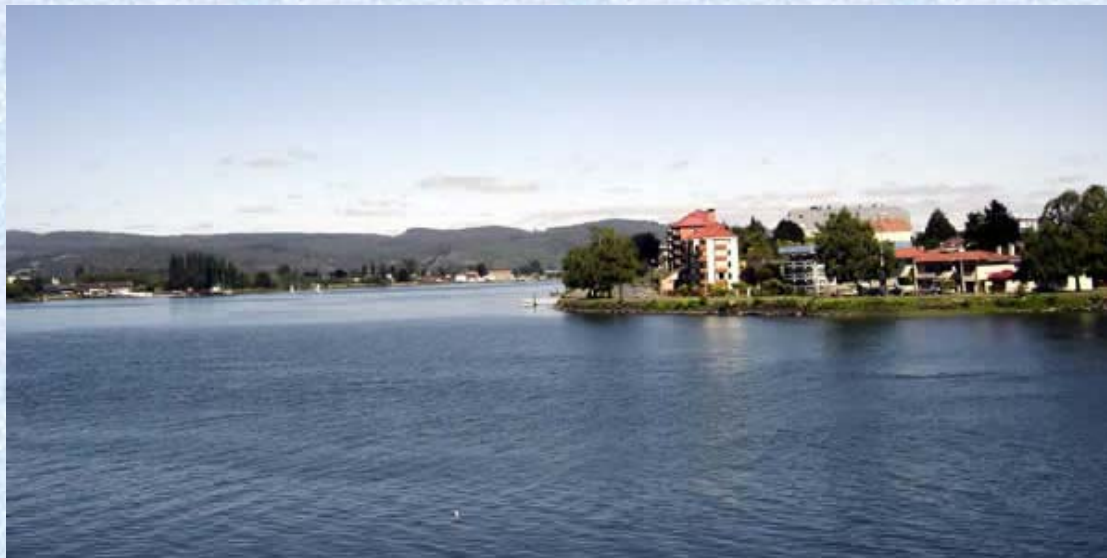
Valdivia before, after and today

“What was the cause of Valdivia inundation and subsidence? and, why today Valdivia is again above the water?”

“The reason of the city subsidence because of subsoil seismic compaction can not explain the later on city uplift to almost the level previous to the earthquake”

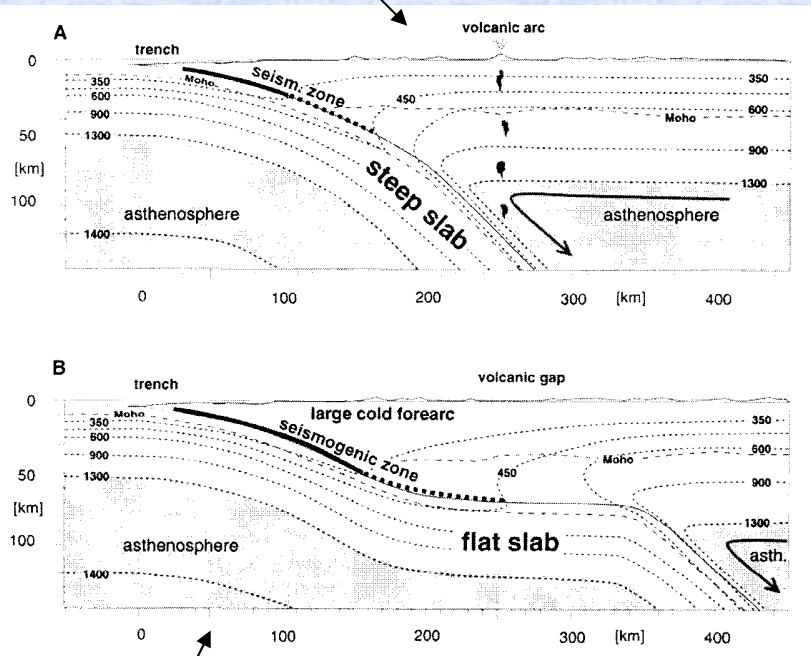
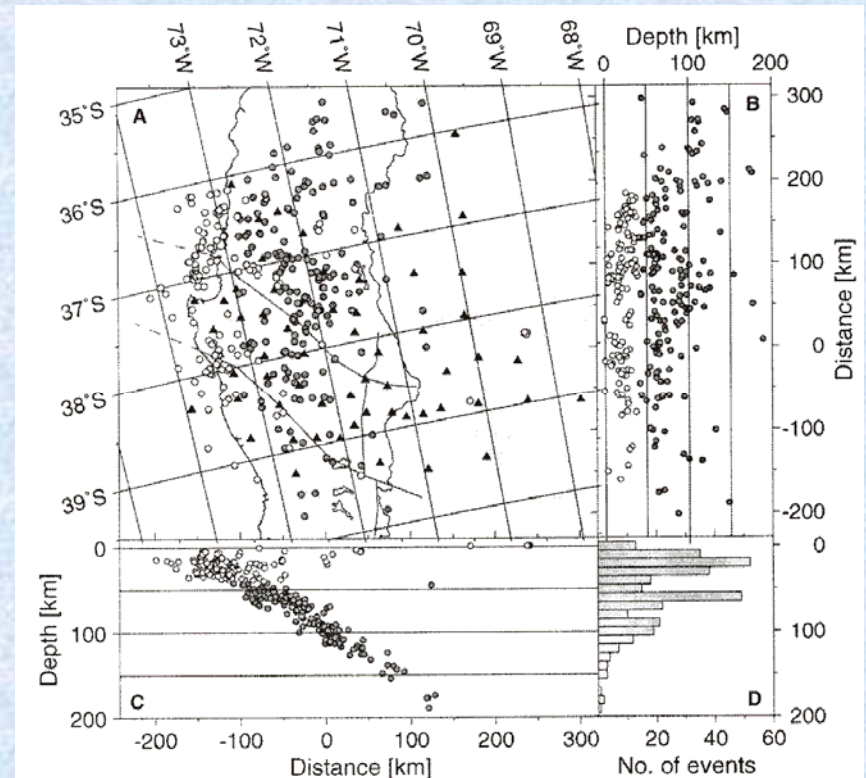
The complex geometry of the Watadi-Benioff zone

South (steep)

North (shallow plate dip)

Epicentres of 333 local seismic events in a three month period

- Decreasing mountain peaks towards the south for coastal and Andes chains
- Flat slab (north) versus deep subduction (south)
- Thickness of the continental crust >70 km in the north and ~ 35 km in the south
- Seismic cycle of subsidence and uplift in coastal areas
