## Case History

### Geotechnical damage caused by the 2010 Maule, Chile earthquake

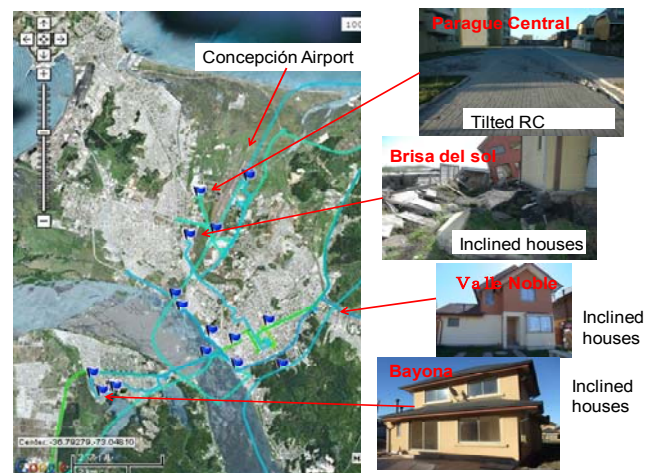
Fig. 3 Sites of liquefaction damage in Concepción

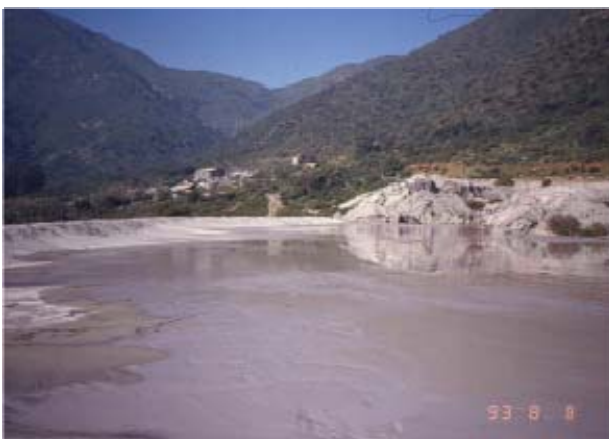
Tailing is a waste material that is produced by mining industries. Valuable minerals are removed from powder of ores and the remaining stone powders are dumped into a water pond (Photo 5). Since the powders are as fine as silt, they sediment in water very slowly and form a loose and liquefiable deposit. Further problem is that this fine grain size reduces the permeability (hydraulic conductivity) of this material and, in case of liquefaction and high excess pore water pressure, the dissipation of high pore pressure is substantially delayed. Therefore, the adverse condition of high pore water pressure and low effective stress lasts for a long time. Moreover, this fine grain has no cohesion, thus increasing the liquefaction probability further. The entire tailing deposit is supported by an embankment made of coarse components of tailing as well. In case of up-stream construction, this embankment is nothing more than a surface coverage, and if the underlying tailings get liquefied, the coverage cannot maintain stability anymore. Hence, a tailing flow occurs.

Photo 5 Reservoir of tailing dam at Veta del Agua in 1993.
