# Geotechnical aspects of damages in Concepción, due to the $M_w$ 8.8 Chile earthquake on February 27, 2010

2011 Pan-Am CGS  
Geotechnical Conference

Manuel J. Mendoza<sup>1</sup>, Efraín Ovando<sup>1</sup>, Felipe A. Villalobos<sup>2</sup>, Miguel Rodríguez<sup>1</sup> & Paulo Oróstegui<sup>3</sup>

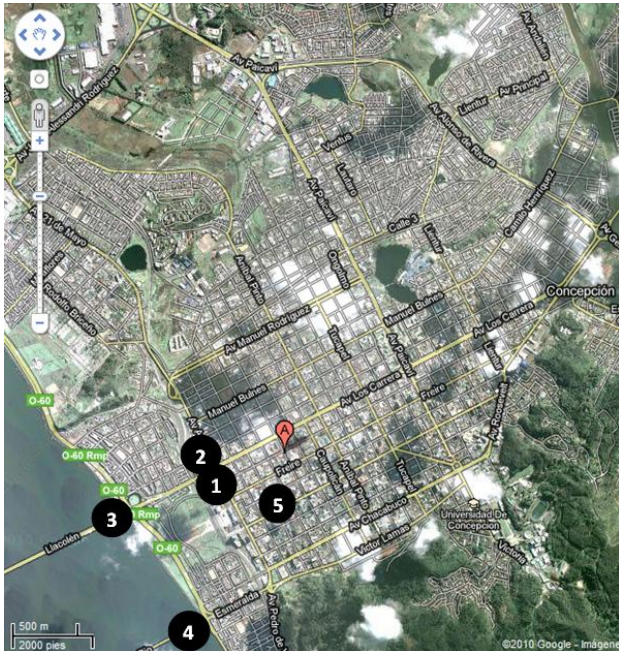
Figure 6. Satellite view of Concepción, Chile (taken from Google, 2010). (Figure numbers are included)

Although damage to constructions is appreciated all over the city, a zone stands out where the damage is more accentuated. The zone is a quadrant of no more than one kilometer per side next to the Bío Bío river, at the height of the Llacolén bridge that connects to the commune of San Pedro La Paz; the following collapses occurred there, which are identified in Fig. 6:

- Building 1, totally overturned building with 14 floors, at Calle Padre Hurtado, between Maipú and Av. Los Carrera. This building will deserve particular attention due to its spectacular collapse, Fig. 1.
- Battery of collapsed silos that stored wheat, located at Calle Desiderio Sanhueza and the same Calle Padre Hurtado, some 200 m away from Building 1, Fig. 2.
- Initial panels of the Llacolén bridge (Chile's second longest), which fell to the ground when one of its ends lost support, repeating what occurred during the Valdivia earthquake in 1960, and requiring the construction of a provisional metallic bridge (Fig. 3) to secure passage to San Pedro La Paz after the panels of the "old" bridge (Fig. 4) suffered multiple collapse.
- O'Higgins Tower, whose floors from the tenth upward totally collapsed, Fig. 5. It is one of the tallest buildings in Concepción, with 21 floors.

As mentioned before, the five sites indicated in Fig. 6 with collapsed structures fall precisely in Zone I of Concepción’s seismic zoning, where in particular the subsoil responds with a natural period of up to 1.7 seconds, aspect that does not happen for buildings

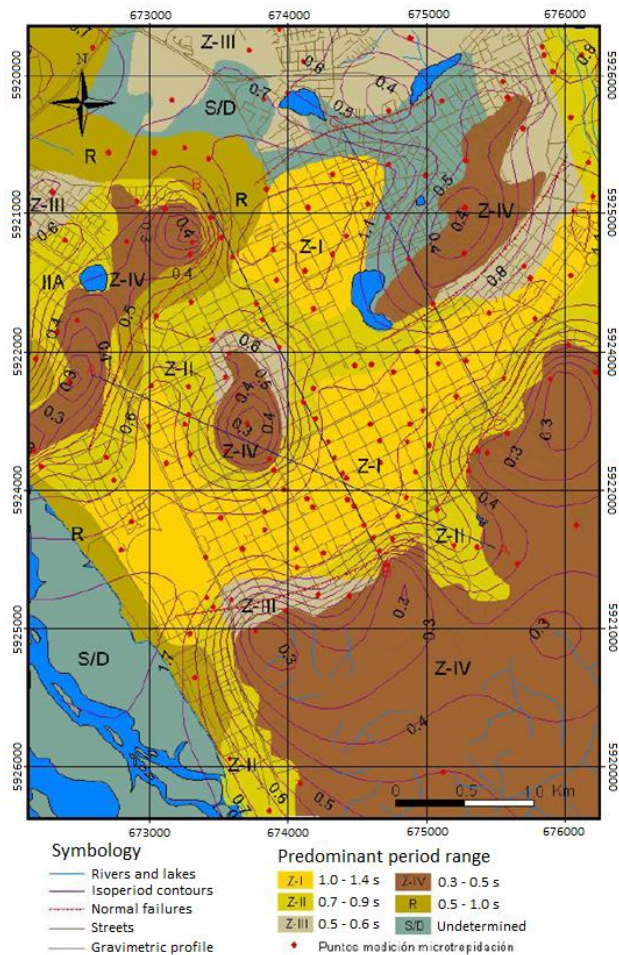
Figure 7. Seismic zoning of Concepción, Chile.

We found relevant information about the city of Concepción's seismic zoning, but no geotechnical zoning. The city's zoning was prepared recently (Ramírez y Vivallos, 2009), identifying six zones in terms of the dominant periods, detailed gravimetry and surface geology, Fig. 7. The study indicates that the morphology

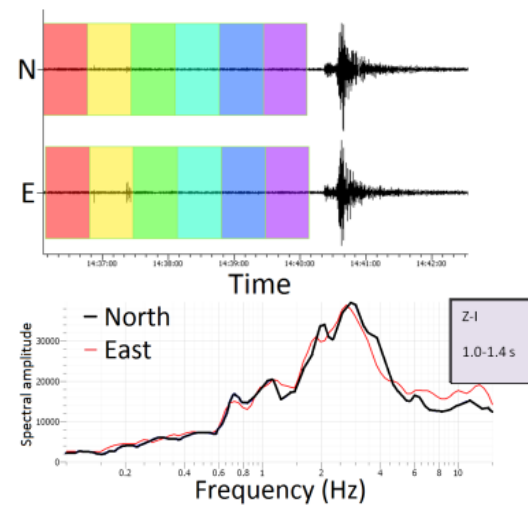
The records of environmental noise presented here, Fig. 8, correspond to the horizontal and orthogonal directions among them, measured on the sidewalk, some 50 meters from O'Higgins tower. Both the amplitude spectra of these records and those obtained from the recording of a replica, Fig. 9, which occurred just as measurements were being recorded, show similar spectral shape, but with different relative amplitude.

Figure 8. Speeds recorded and spectral amplitudes measured on sidewalk near O'Higgins tower in Concepción, 2010-03-13 (Six windows of 40 seconds each were recorded).

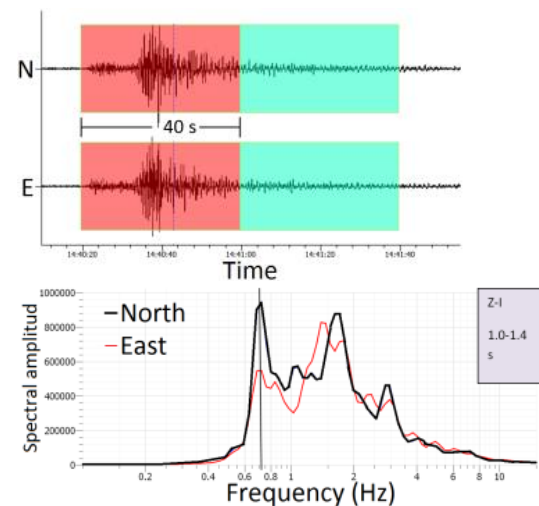
Figure 9. Replica's accelerograms and spectral amplitudes recorded and measured at sidewalk near O'Higgins tower in Concepción, Chile.

The event's spectrum has a very clear spectral maximum on approximately 0.71 Hz, in both components. Also, there are two additional maximums, on approximately 1.4 Hz for the east component and 1.6 for the north component, as well as another one near 3 Hz. The amplitudes associated to the spectral maximums are smaller for increasing frequencies. Both the difference in dominant frequency –certainly significant– associated to the maximum near 1.5 Hz, and the fact that this maximum is not manifested in the noise spectrum, stand out.

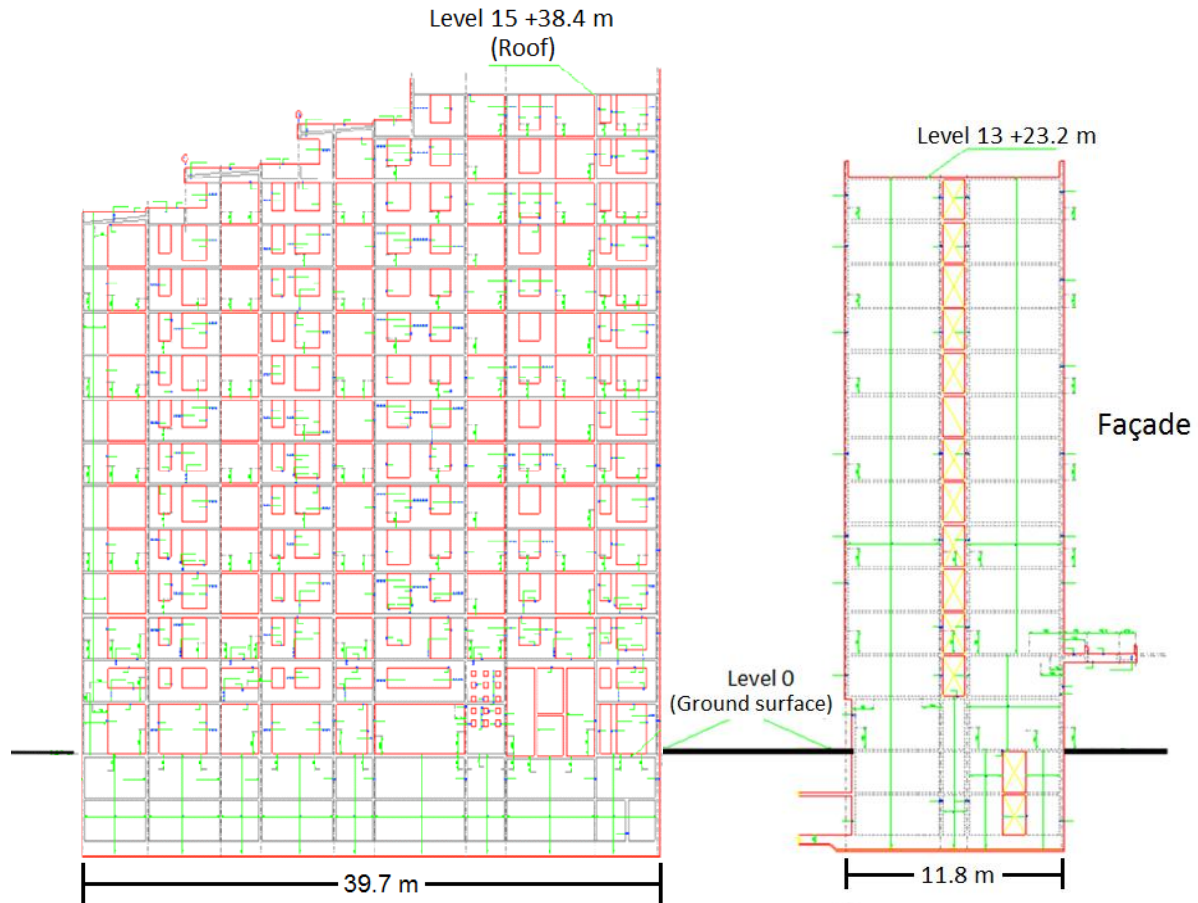
Figure 20. Longitudinal section of Alto Río building.

With respect to the behavior of its foundation, the Alto Río building that completely overturned in Concepción, Fig. 1, deserves a particular review. The construction had 14 floors and two basements. Fig. 20 shows a longitudinal cut of the building, which had a floor plan proportion of length versus width of 3 to 1. The structure consisted of reinforced concrete walls, typically 20 cm thick, and floor slabs also of reinforced concrete, of 15 cm thickness. The building reached a height of approximately 40 m. The foundation was solved with a solid slab of reinforced concrete 80 cm thick in the area under the tower, set from ground level at -5.94 m, from which the concrete walls rose. In the parking area that was located behind the

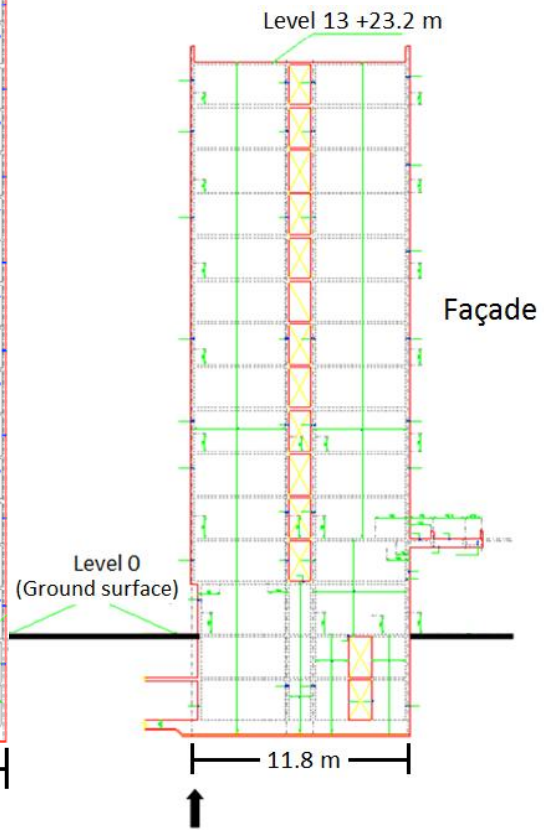
Figure 21. Transversal section of Alto Río building.

The failure occurred when the vertical elements of the ground floor and/or basements collapsed, apparently from compression, on the vertical back plane opposite that of the façade, indicated with an arrow on Figs. 21 and 22. Fig. 22 shows the ground floor plan, indicating the area occupied by the building itself, and the underground parking behind it and out of its projection. Apparently, the reduction or non existence of walls along the longitudinal axis of the building's back façade, indicated with arrows, seems to have propitiated the failure by compression which, in turn, gave origin to the failure by tension of the front façade's vertical elements. The building as a whole overturned with rotation from the ground floor level, the vertical elements of the façade zone failing by tensile rupture, Fig. 23, and therefore the building fell on its back.
